# Sony XAV-AX100 USB Cable Replacement

Follow this guide to replace the USB cable on a Sony XAV-AX100 radio.

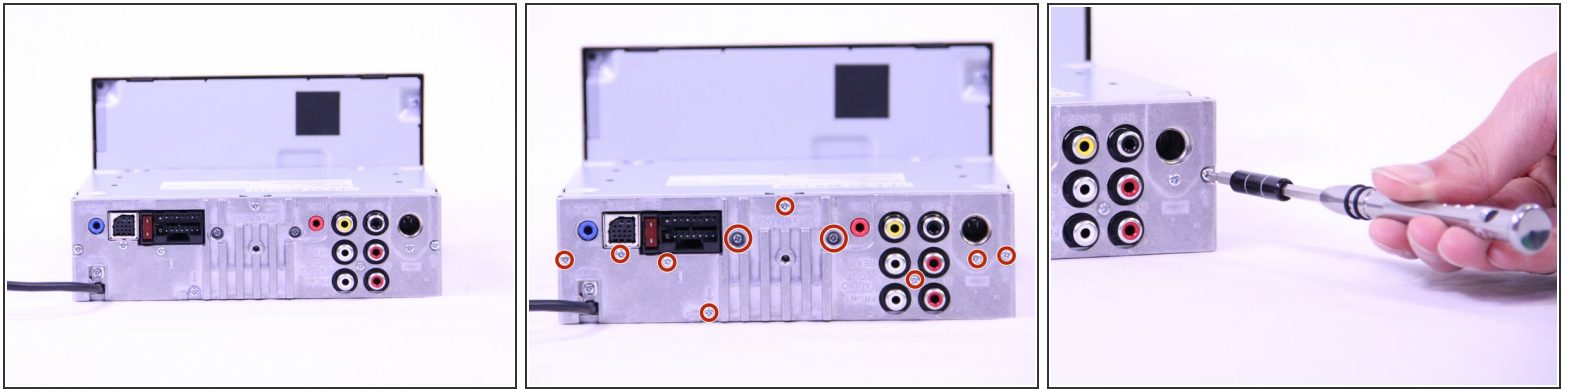
## Step 1 — USB Cable

- Place the device on a flat surface, upside down, so the bottom of the screen would be facing upwards.
- Remove the ten 3.5mm Phillips #0 screws from the back plate.

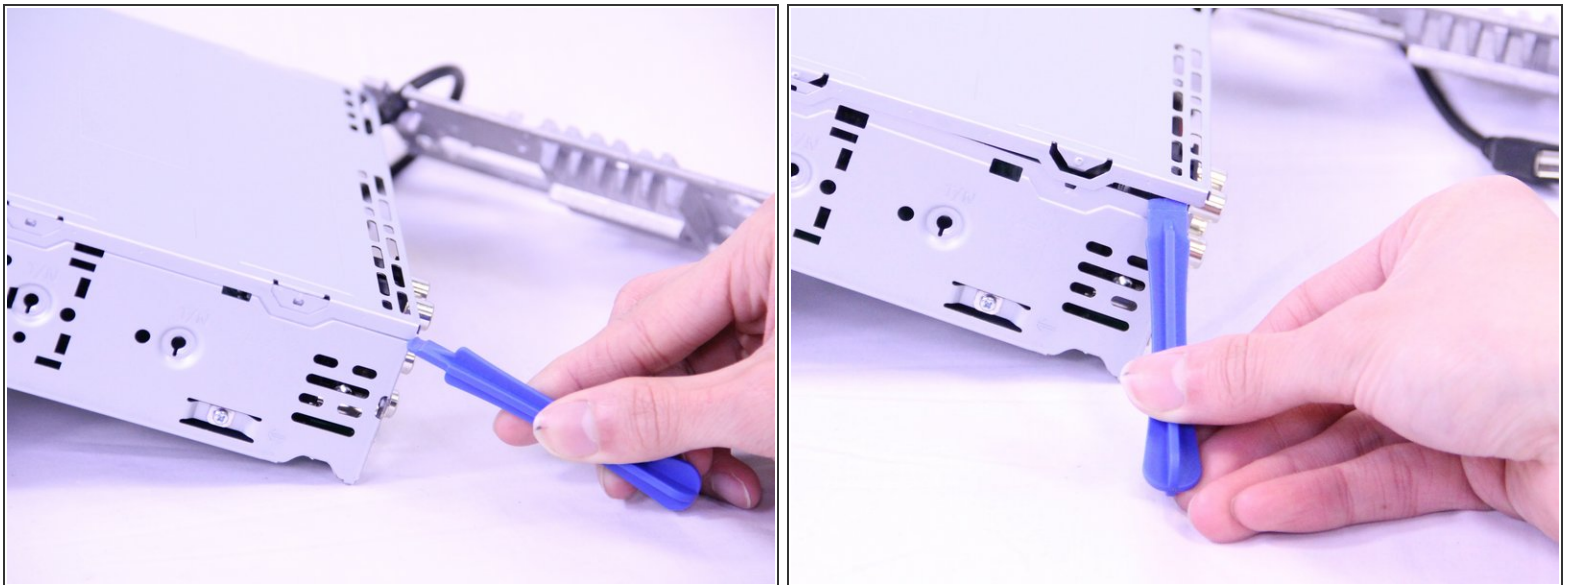
## Step 2

- Use a plastic opening tool to remove the back plate.
- ⓘ Don't remove completely as there will still be cables connected.

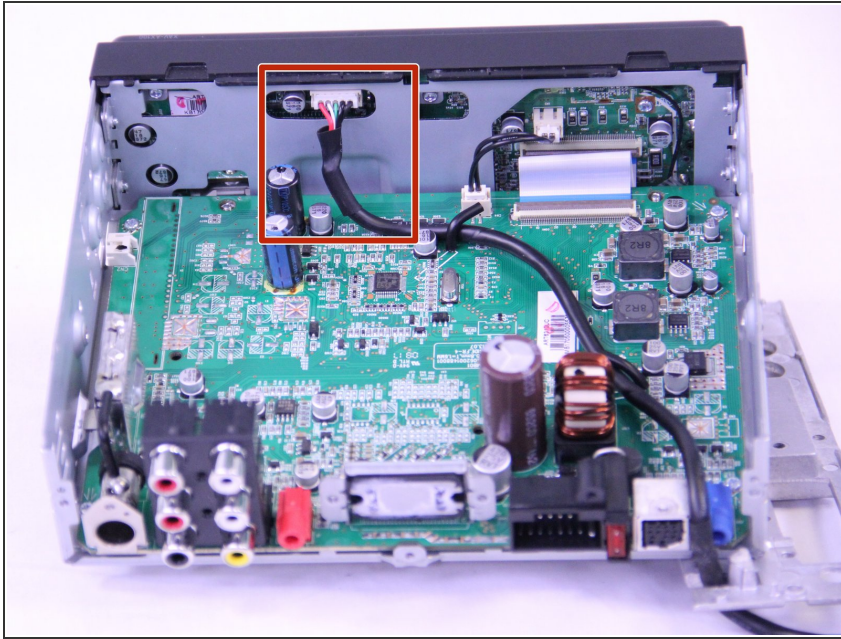
## Step 3

- Disconnect the USB cable from the display board.

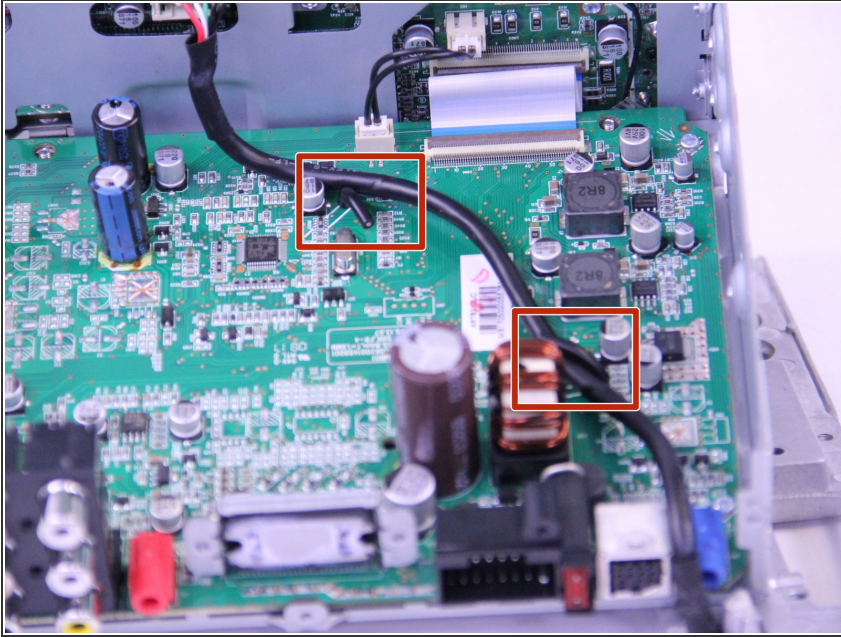
## Step 4

- Adjust the rubber holders that are keeping the USB cable still on the motherboard, so you can remove the cable entirely from the inner compartment.

⚠ The rubber holders are extremely sensitive to any applied force. Therefore, be careful while turning them around.

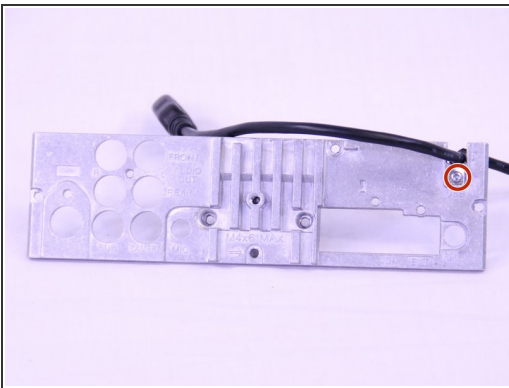
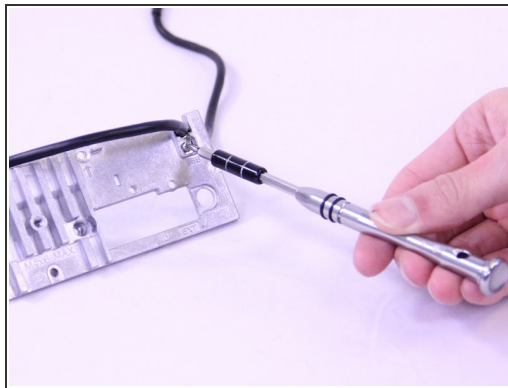
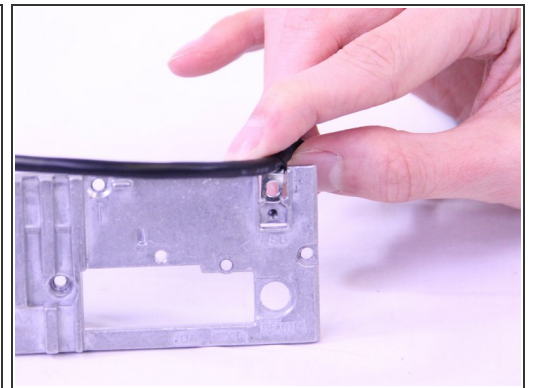
## Step 5

- Remove the 3.5mm Phillip #0 screw that secures the USB cable to the back panel.
- Pull the USB cable off of the back plate.
