MacBook Pro 13" Touch Bar 2018 Keyboard Teardown

Teardown of the MacBook Pro's 3rd-generation butterfly keyboard, performed July 19, 2018.

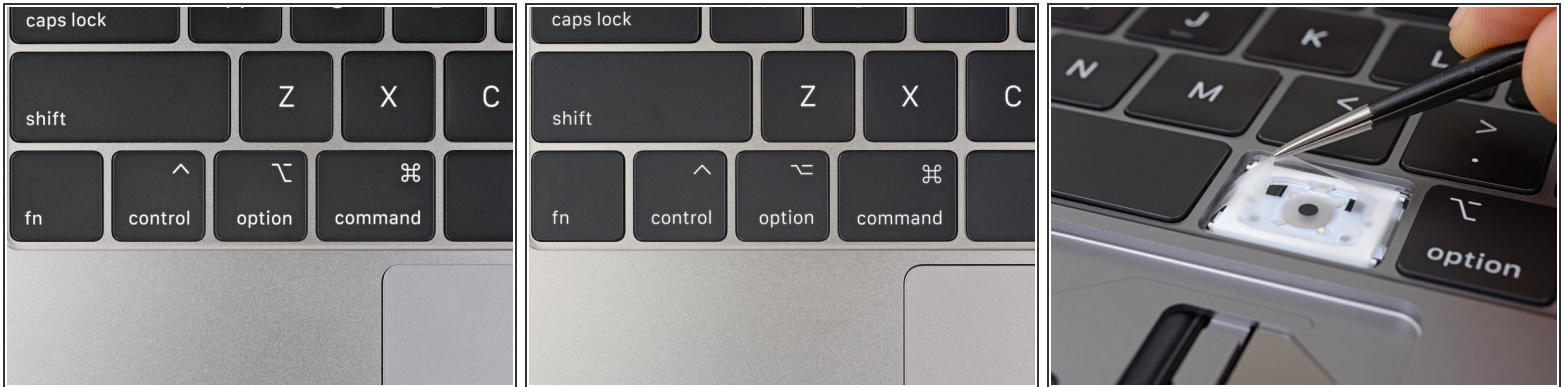
Step 1 — MacBook Pro 13" Touch Bar 2018 Keyboard Teardown

- Visually speaking, the new keyboard is *strikingly* similar to the previous model. In the first image you can see the slightly taller option ⌥ symbol on the new model.
 - The new keycaps measure ever-so-slightly thinner (about 1.25 mm, vs. 1.50 mm on the 2017 model), allowing for easier removal with less risk of damage. We also note that the [space bar's](#) inner workings have been subtly redesigned.
 - And of course, there's the new silicone layer draped over the delicate butterfly mechanisms.
- ⓘ A while back, Apple [filed a patent](#) for all sorts of keyboard ingress-proofing methodologies. And today [Apple may have confirmed](#) the silicone's true purpose as dust protection.

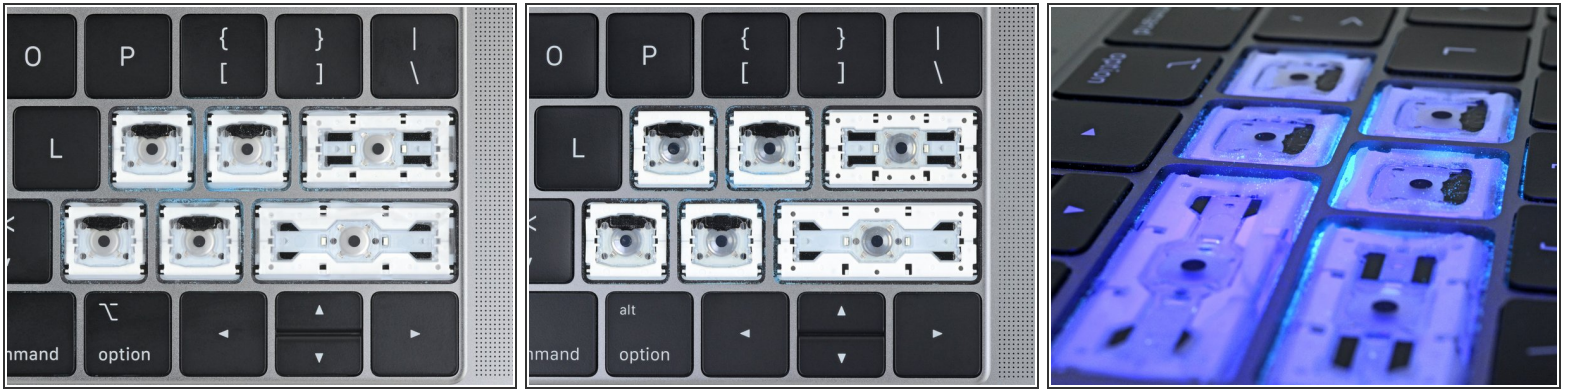
Step 2

- Let's address the *key* concern on everyone's minds: do the new silicone implants work? Here's our highly scientific analysis:
 - We sprinkled some blue powder on the keys, mashed on them, and then popped the keycaps off to see where the powder went.
 - **Mild success!** The third-gen keyboard (first image) routes *most* of the powder towards the edge of the key and away from the delicate butterfly mechanism. Last year's mechanisms (second image) don't fare so well.
 - Accelerated testing (aka more powder, more typing) pushes glowing dust past the membrane's not-infallible defenses and onto the dome switch.
- 👉 Shoutout to our buddy and fellow Mac enthusiast [@dani](#) for the fluorescent powder idea! Thanks Dan.

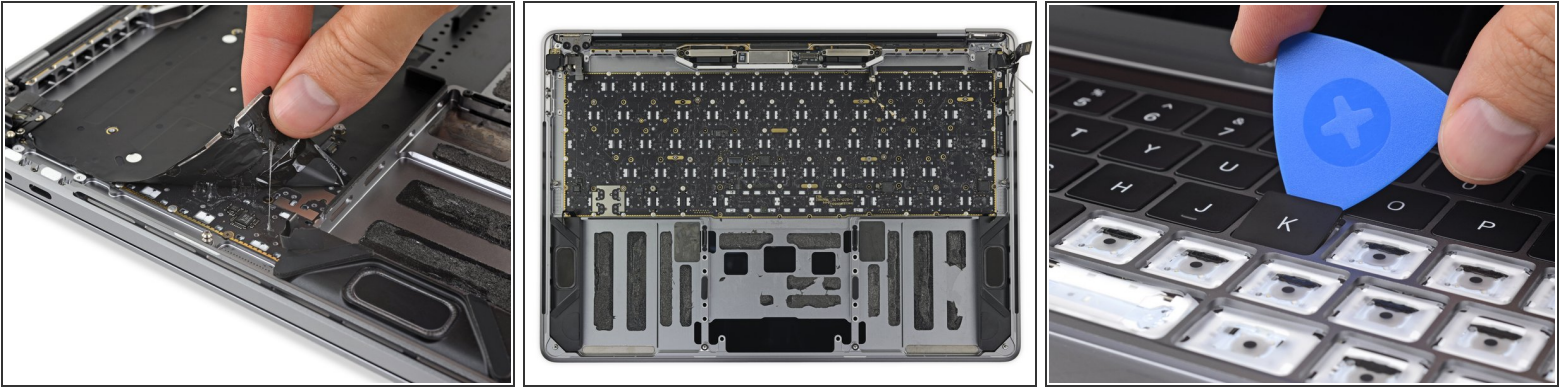
Step 4

- Now that we've extensively explored the topside of the keyboard, it's time to *shift* our attention underneath, where our teardown begins in earnest.
- First we peel back a heavily-glued shield, exposing the large keyboard base.
- Before going any further, we have to return to the top of the keyboard and remove *every* remaining keycap to get access to the silicone barrier.

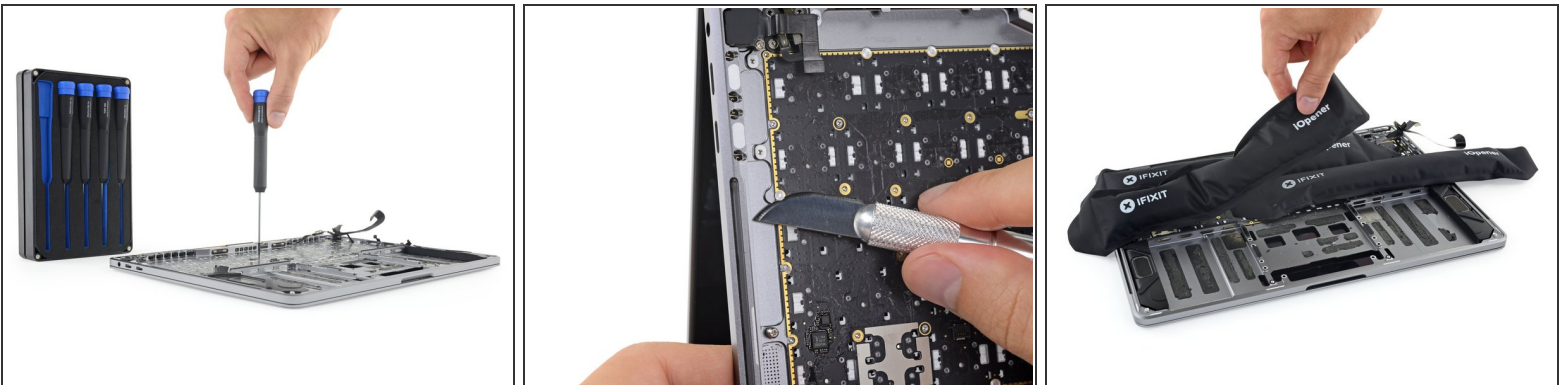
Step 5

- Just three more stages in this gauntlet before the keyboard can *ESCAPE* its prison:
 - In our line of work, P2 pentalobe screws are as common as, well, iPhones—so we've got the [professional tools](#) to tackle them.
 - Apparently security screws aren't secure enough, so the keyboard also features *rivets*. We had to carve off over a dozen of these single-use posts in order to proceed.
 - What remains is a mild layer of adhesive; we pile on the iOpeners and heat things up.

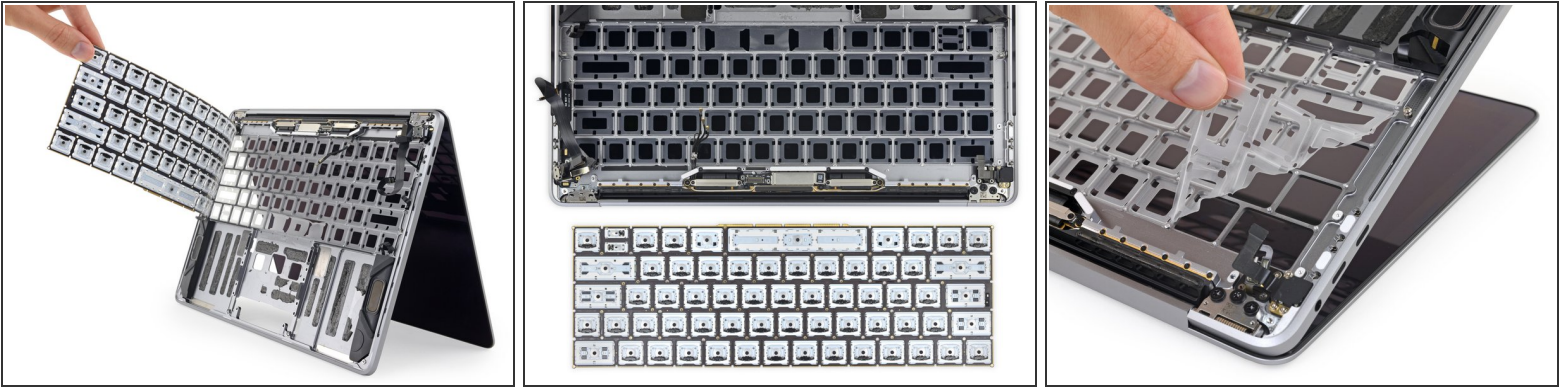
Step 6

- With all of its defenses thwarted, the keyboard PCB gives way and peels from the chassis, fully exposing the membrane that was sandwiched underneath.
- The membrane happens to be a single sheet of die-cut silicone, reminiscent of some [old-school keyboard covers](#).
- Apart from the improved keycaps, this keyboard design is still pretty lacking in serviceability. The sheer amount of disassembly required, along with obstacles such as rivets and adhesive, makes replacing a failed keyboard seriously impractical.
