Pioneer FH-X730BS Disk Drive Replacement

This guide shows you how to replace a Pioneer FH-X730BS disc drive.

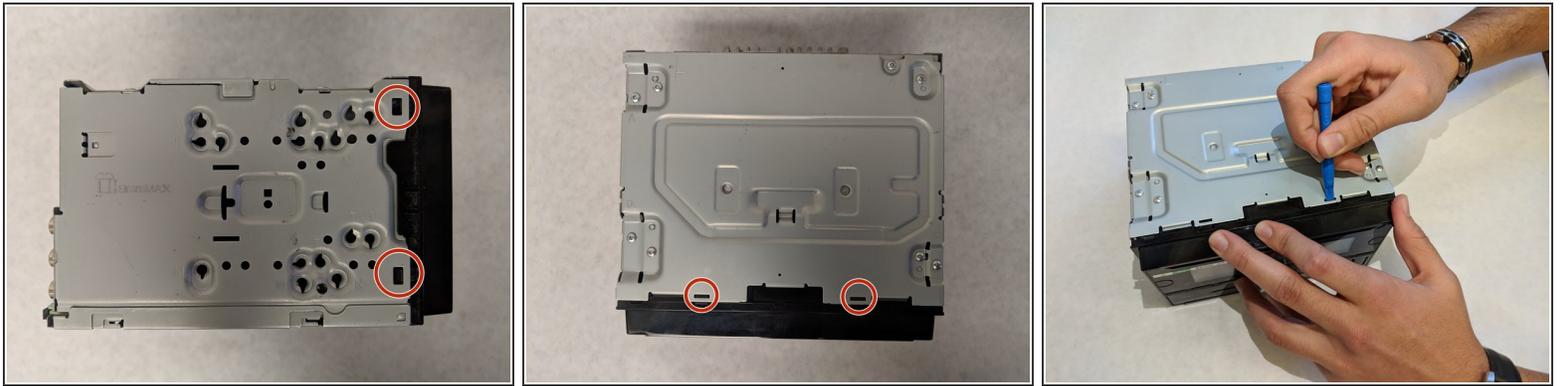
Step 1 — Disk Drive

- Apply pressure to the tabs on each side using the plastic opening tool.
- You will need to pull the face away from the frame while unhooking the tabs.

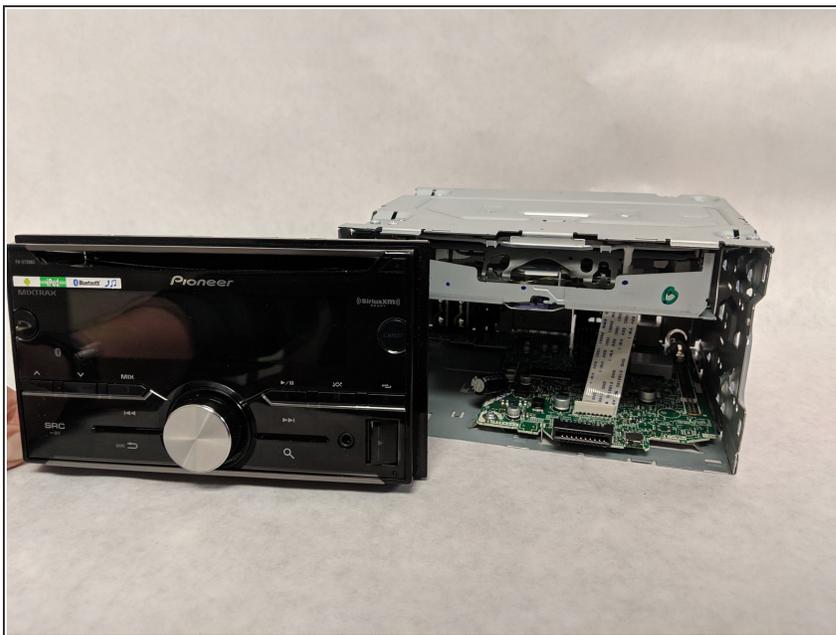
Step 2

- After removing the stereo face from the frame, it should look similar to this.

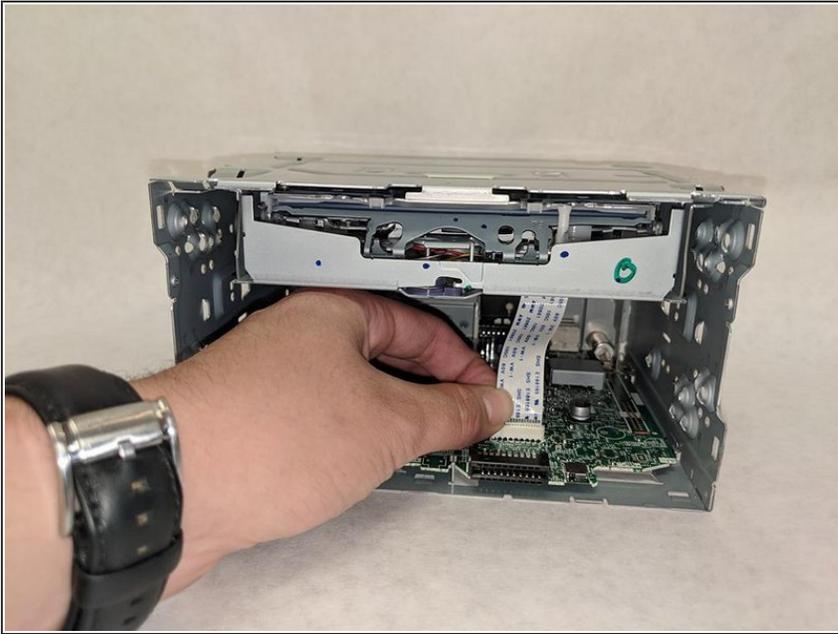
Step 3

- Remove the ribbon wire from where it is being held in place. This can be done by applying force upwards.

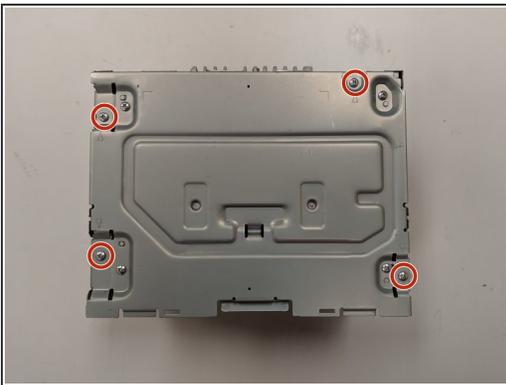
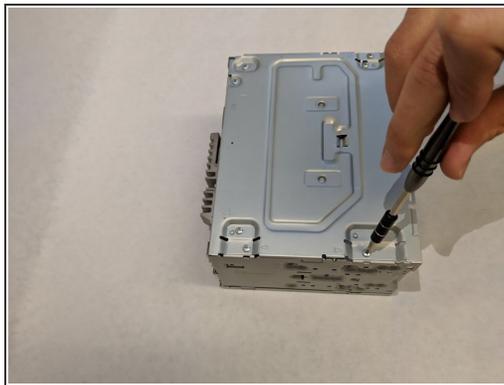
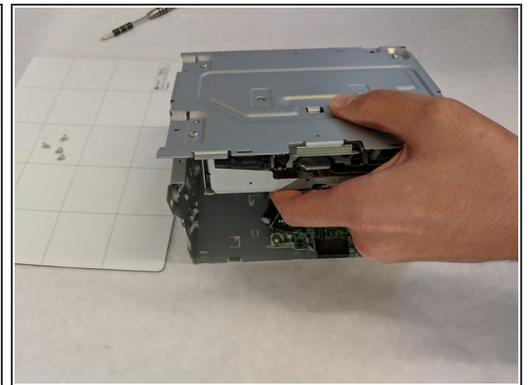
Step 4

- Unscrew the four 7.3 mm outer screws on the top to remove the top face from the rest of the frame.

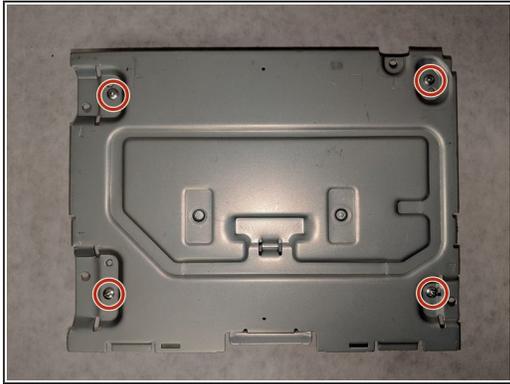
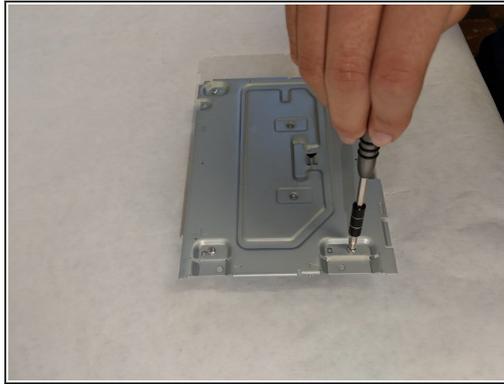
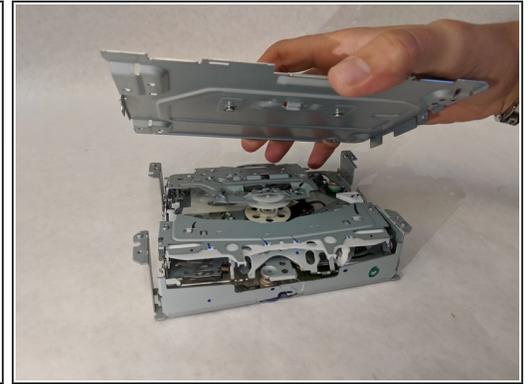
Step 5

- Unscrew the four inner screws that are 7.3 mm long using a Phillips #1 head screw driver to remove the disk drive from the top face plate.
- Replace the old disk drive with a new one.
