Rowenta silent force extreme RO5931 main brush

Teardown

The push button did not lower the brush...

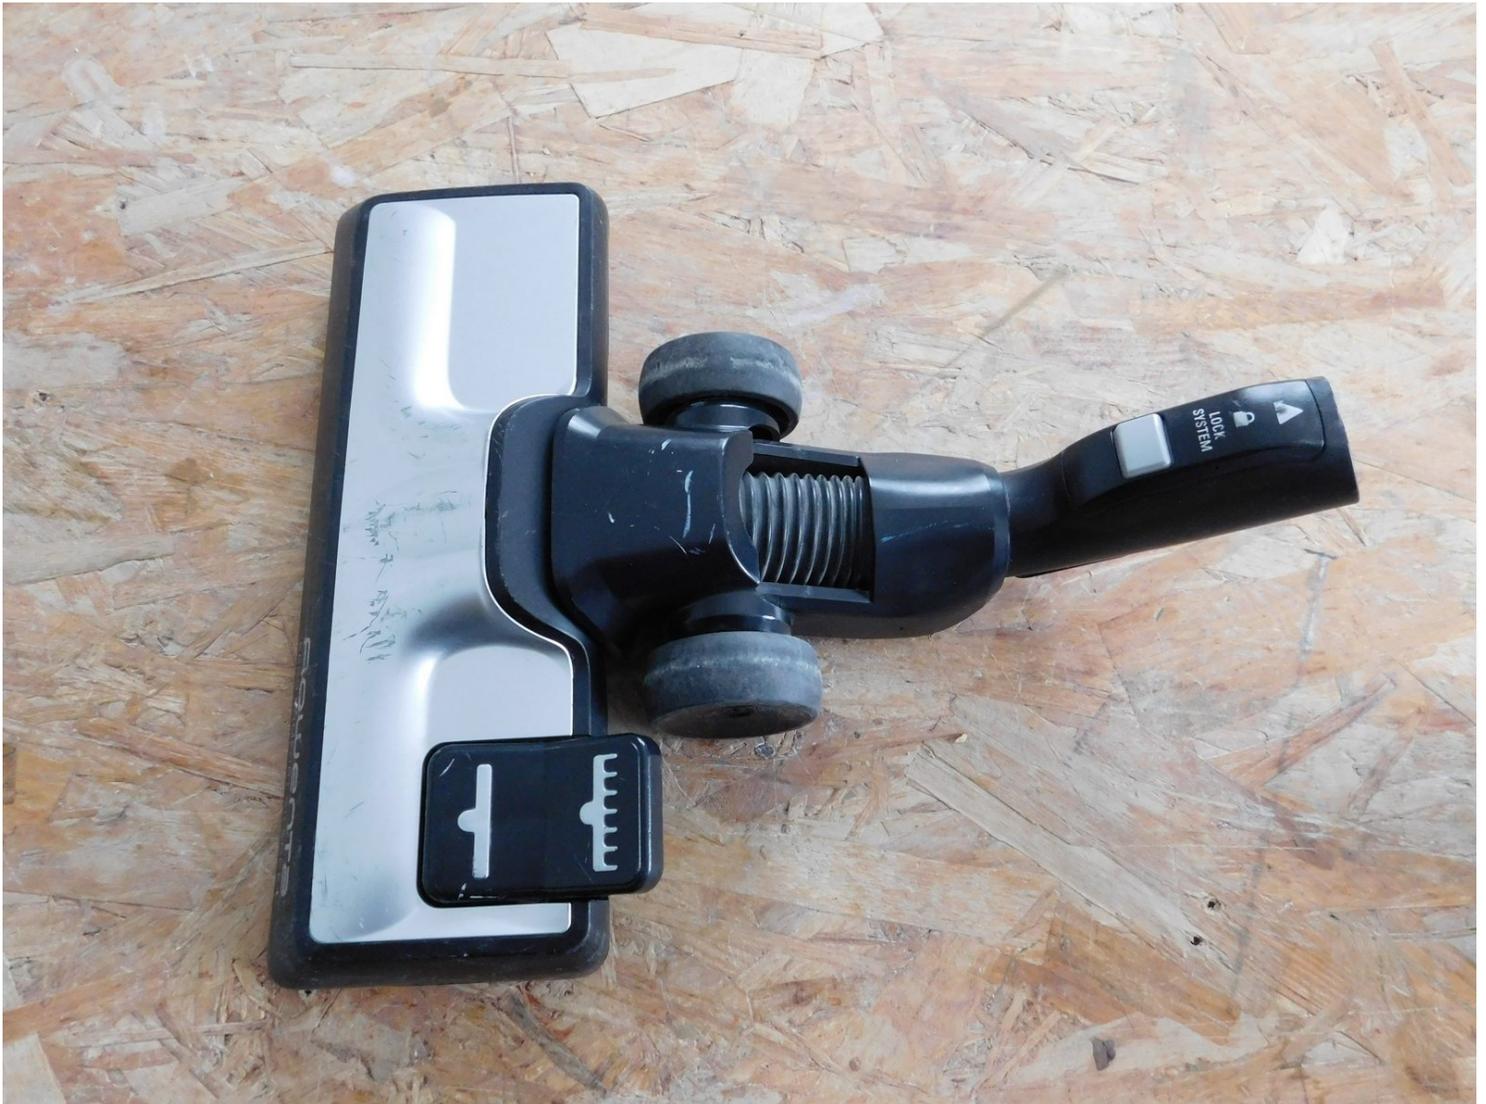
The push button did not lower the brush properly : a broken plastic inner-piece was hindering the lowering of the brush. This guide explains how to tear down the brush and put the broken piece away.
