# Garmin Nüvi 205W LCD Display Replacement

Replacing Garmin Nüvi 205W LCD Display

This Garmin had a cracked front glass/digitizer. Due to cost effectiveness I replaced the complete front panel. Replacement cost \$20.

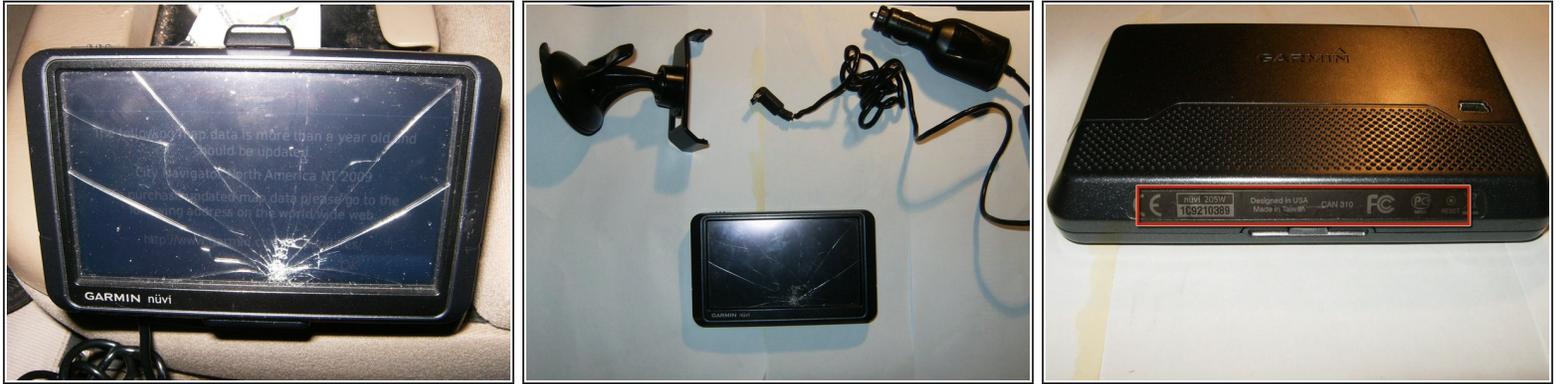
## Step 1 — LCD Display

- The cracked screen is clearly visible. LCD is still functioning, but obviously no touch function.
- Remove the holder as well as the power cord from the back of the GPS unit.
- The Nüvi uses two screws that are hidden underneath the label on the bottom.
