Xbox One S All Digital Edition Wifi Card Replacement

If the Xbox is unable to find or connect to the internet / WiFi / network, use this guide to fix this issue.

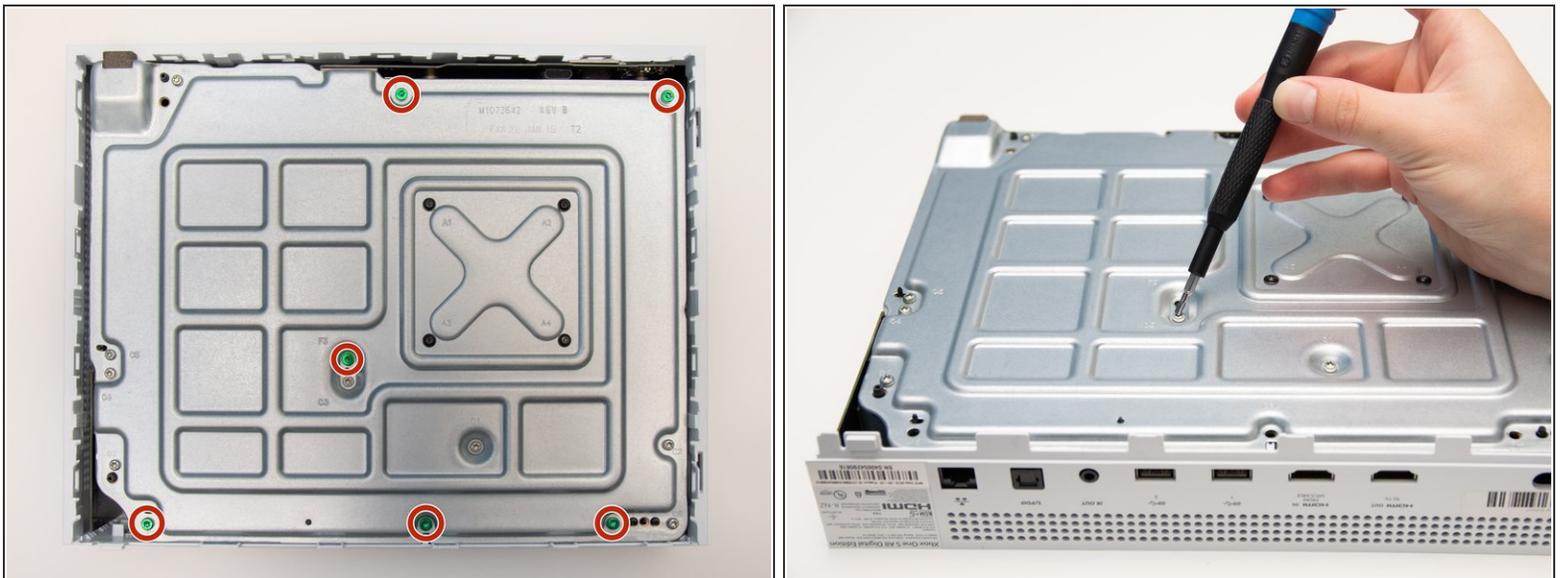
Step 2

- Remove the six 50 mm green screws (labeled F1-F6) from the metal chassis using a Torx 10 screwdriver.
- ⓘ These screws hold the top cover of the plastic enclosure to the chassis.

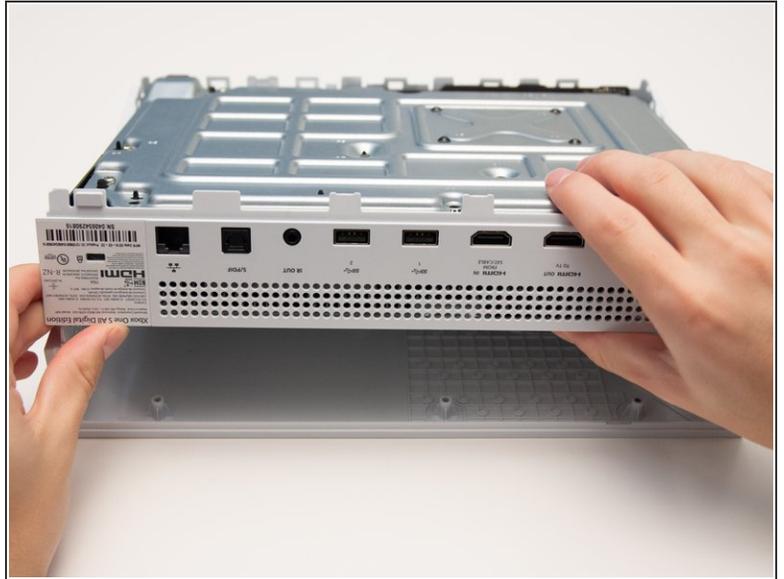
Step 3

- Apply pressure to peel off the sides of the casing.
- Separate the metal chassis from the top cover, lifting the back of the chassis up and away from the top cover.
- **i** The plastic back panel is meant to stay attached to the metal chassis.

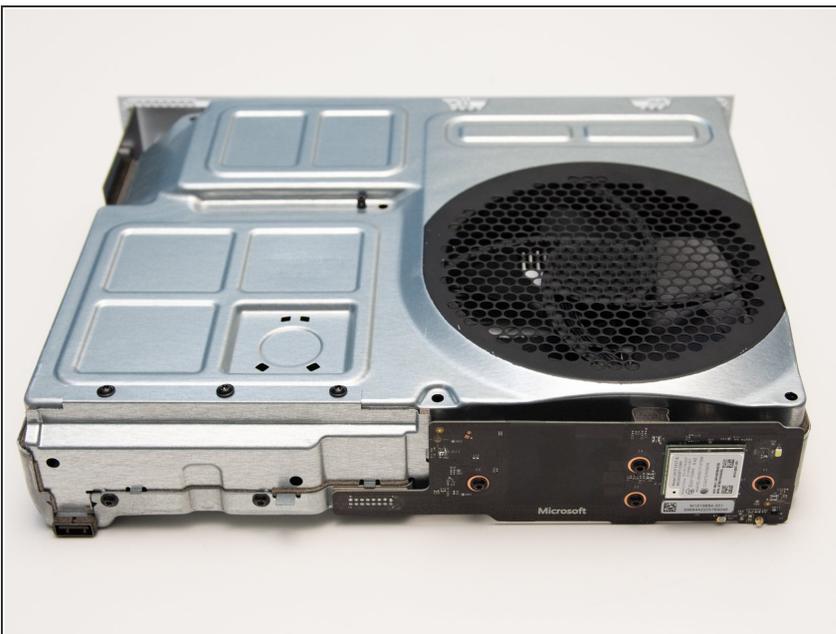
Step 4

- Flip the metal enclosure so that the fan cover is on top.

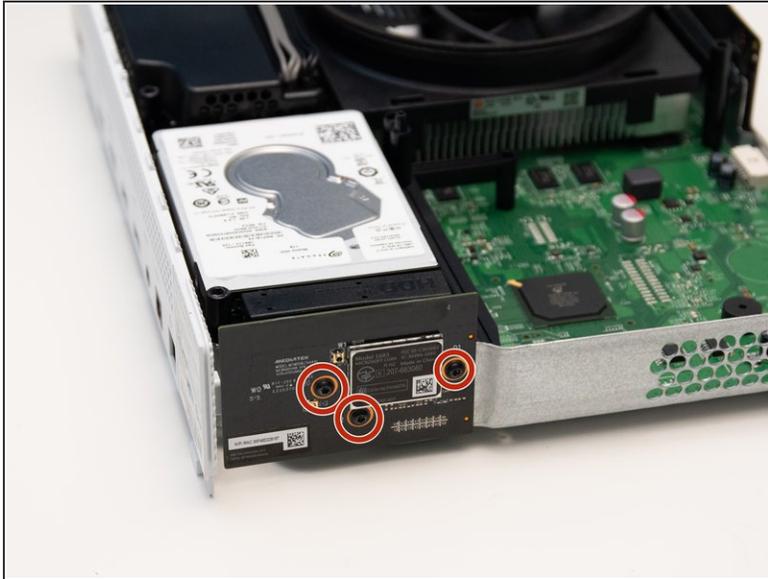
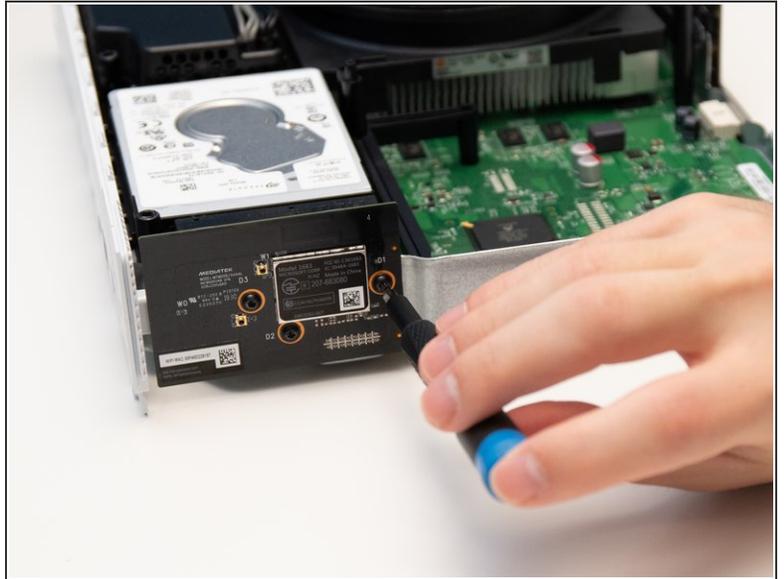
Step 5 — Wifi Card

- Remove the three 15 mm screws with the Torx T8 Security Bit Screwdriver.
- ⓘ The top of the metal chassis has been removed in the picture, but is not necessary for the replacement.

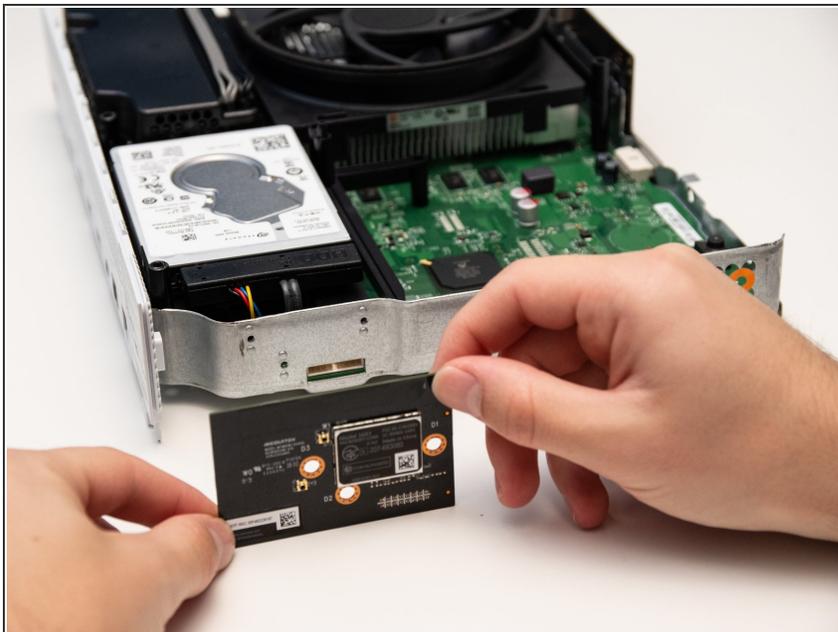
Step 6

- Carefully remove the WiFi Card from the metal chassis.
