Lenovo ThinkPad X1 Carbon (2nd Gen) USB Audio Port Board Replacement

Use this guide to learn how to replace the USB audio port board in your Lenovo ThinkPad X1 Carbon (2nd Gen).

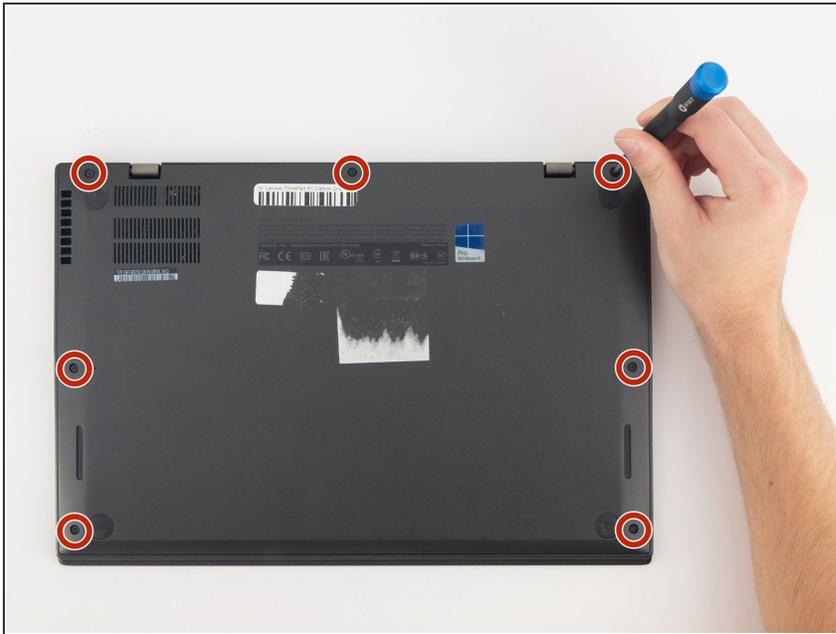
Step 1 — Back Cover

- Using a Phillips #0 screwdriver, remove the seven 7mm screws holding the back cover onto your computer.

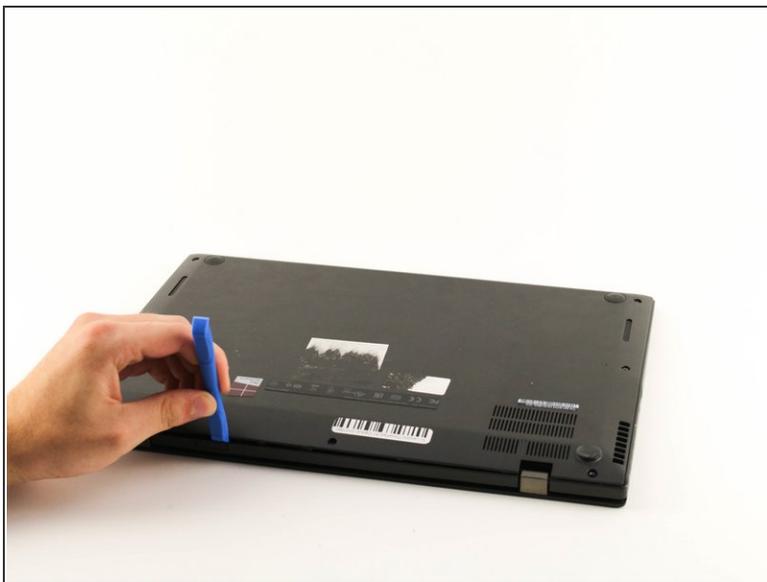
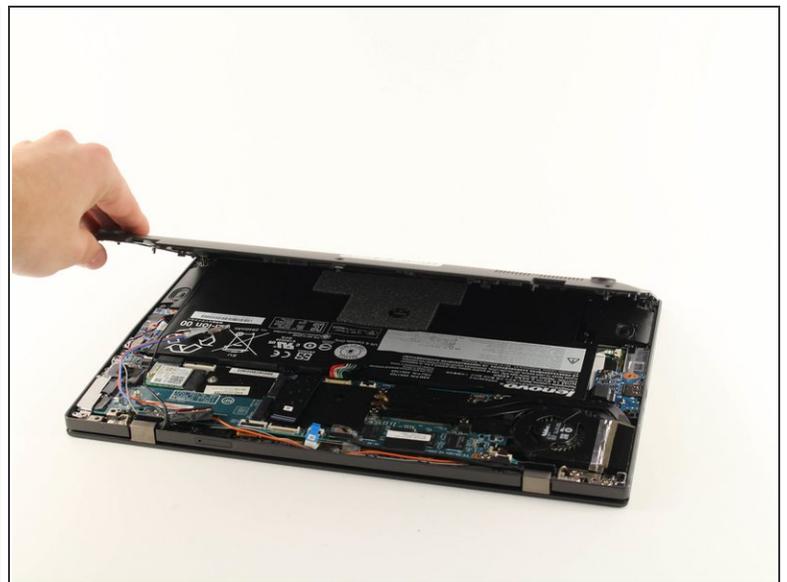
Step 2

- Use a plastic opening tool or your fingers to pry off the cover.

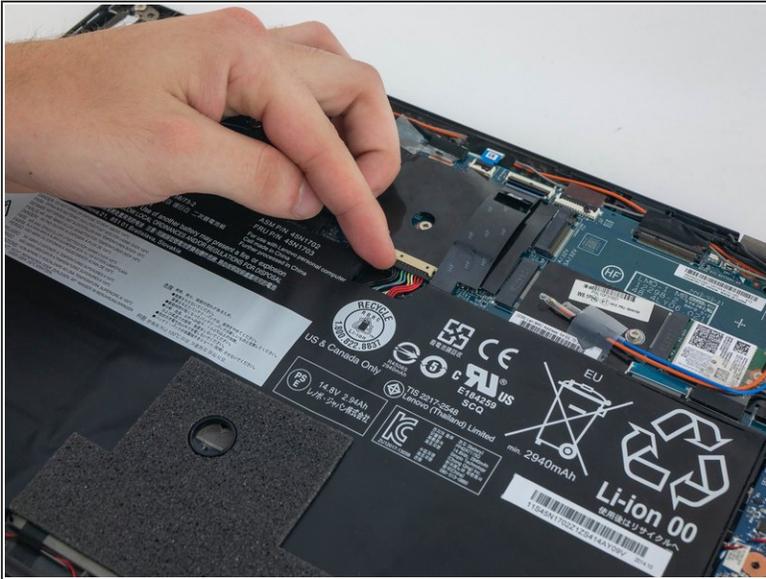
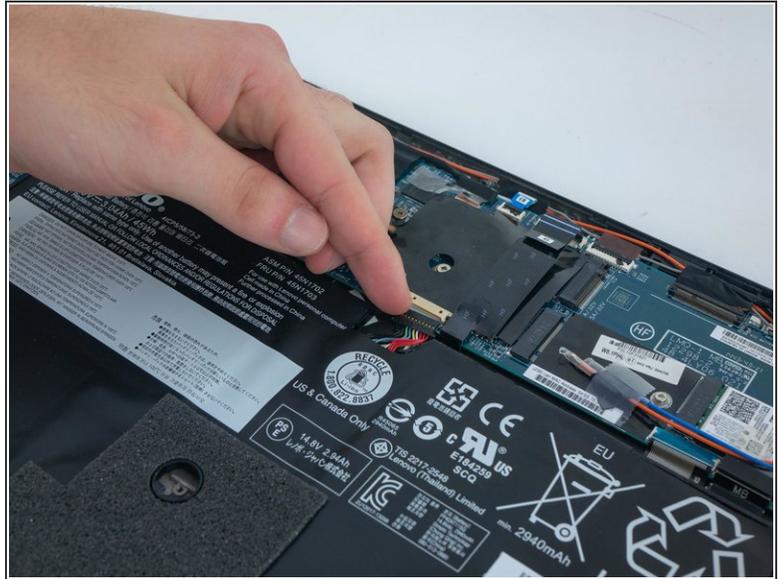
Step 3 — Battery

- Using your fingers, disconnect the battery from the motherboard.

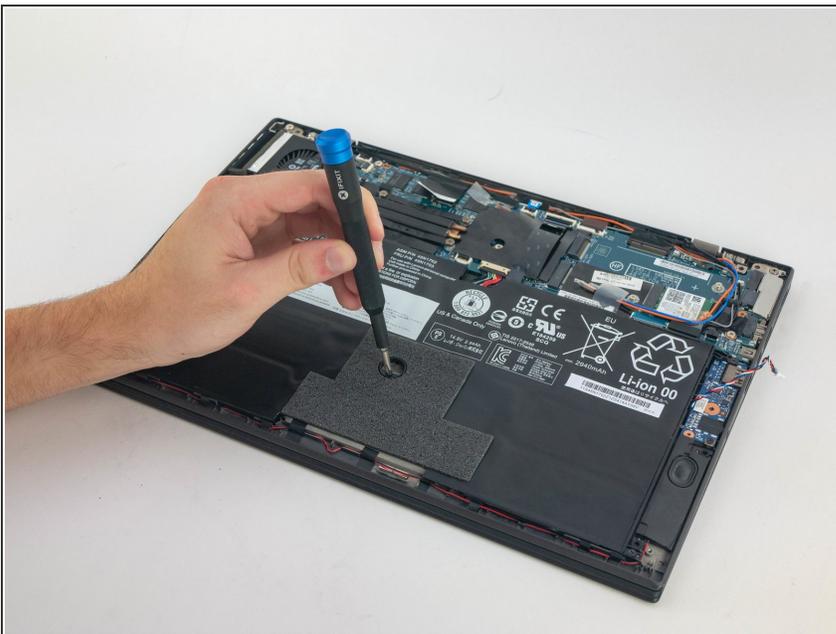
Step 4

- Using a Phillips #0 screwdriver, unscrew the five 4.3mm screws attaching the battery to the computer.

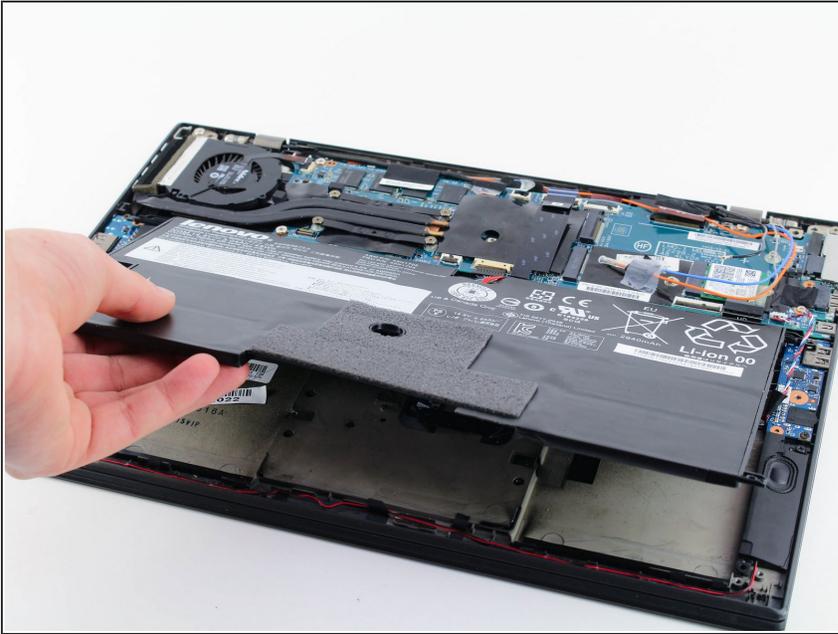
Step 5

- Remove the battery by pulling it directly towards you.

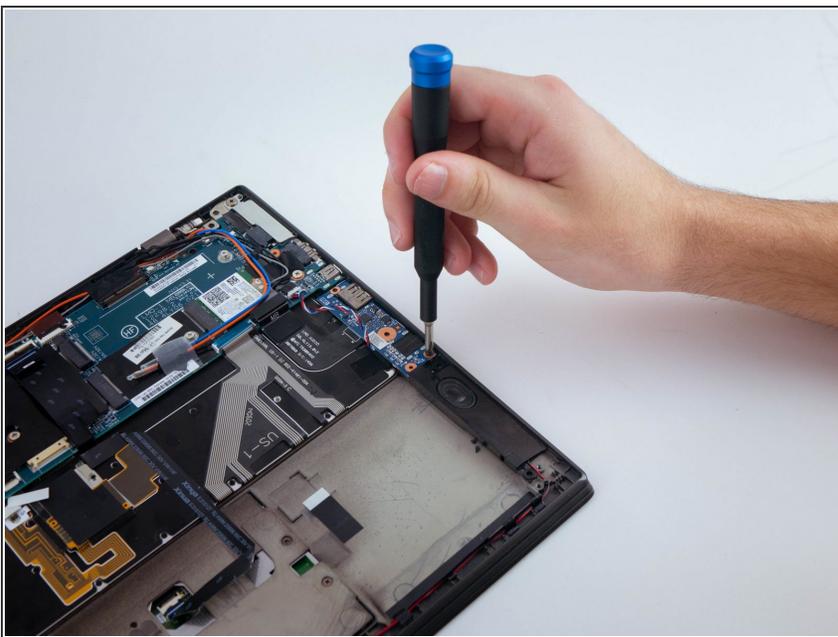
Step 6 — USB Audio Port Board

- Use a Phillips #0 screwdriver to remove the 2.9 mm screw that is holding down the USB audio port board.

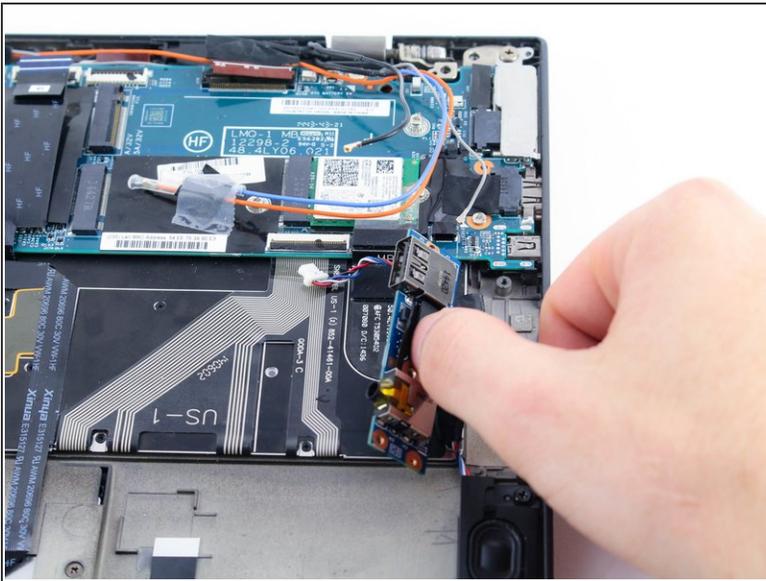
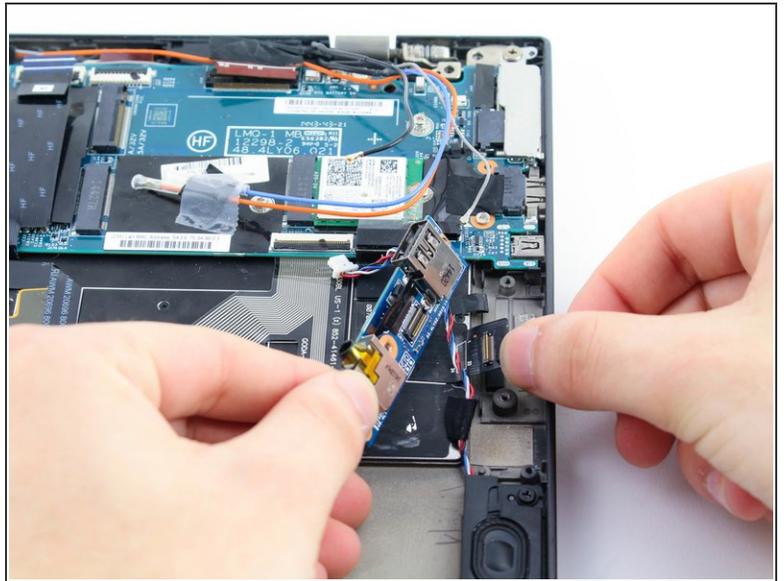
Step 7

- Undo the clasp under the USB audio port board.

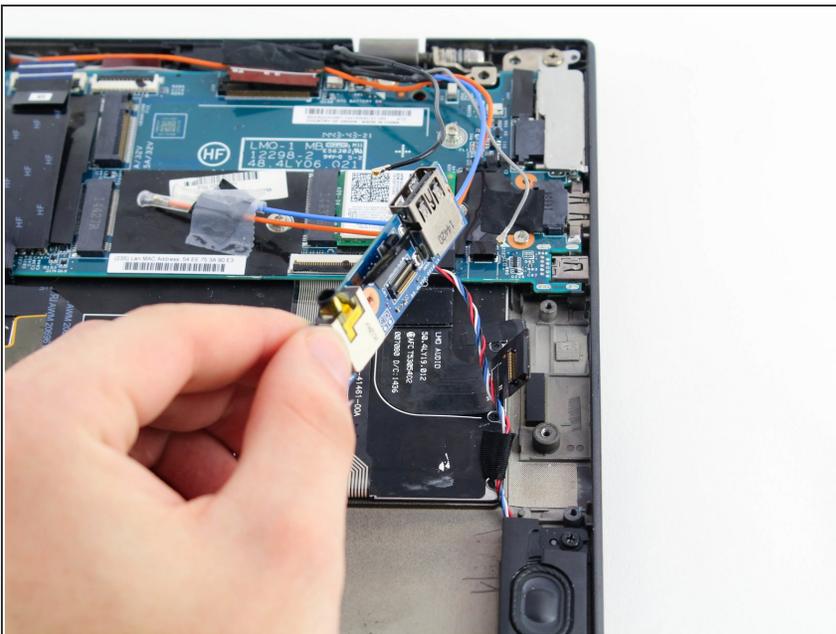
Step 8

- Remove the USB audio port board from the laptop.

To reassemble your device, follow these instructions in reverse order.
