How To Fix iPhone 11 Pro Max Face ID Not Available - Motherboard Repair

Written By: Phryne

iPhone 11 Pro Max
Face ID
Not Working Repair

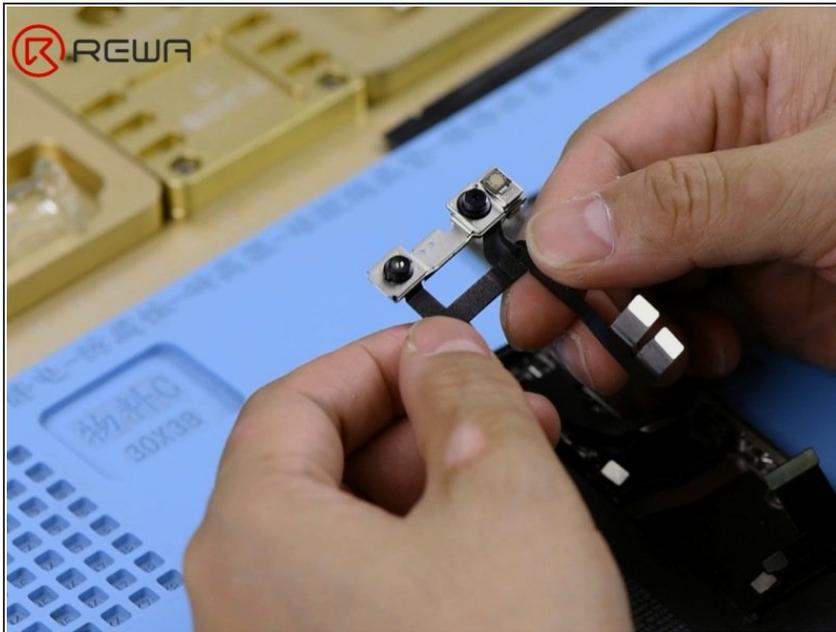
Step 2

- Let's check Face ID parts first. Take apart the phone and take out the motherboard.
- Check the earpiece speaker and sensor flex cable. Nothing goes wrong. The dot projector flex cable, the infrared camera flex cable and the front camera flex cable also haven't been damaged.
