# 2008-2010 Mitsubishi Lancer Radio/CD Player Replacement

Learn how to replace the radio/CD player unit for 2008-2010 Mitsubishi Lancers.

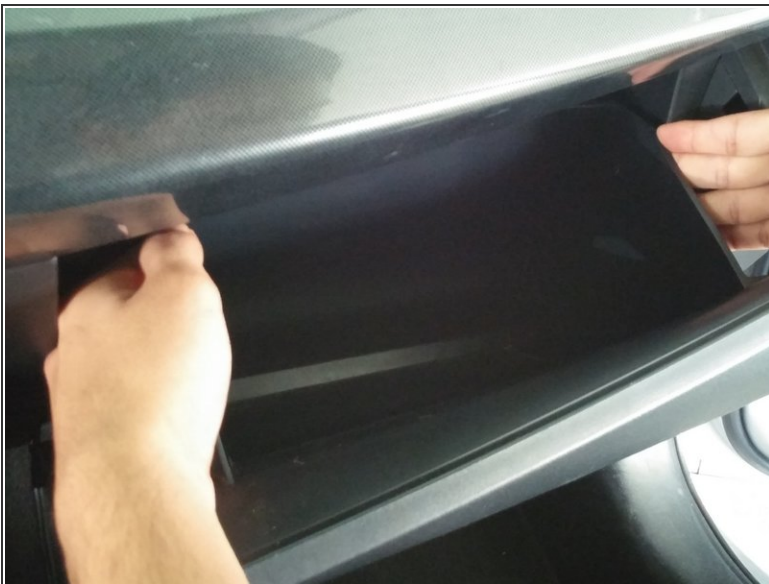
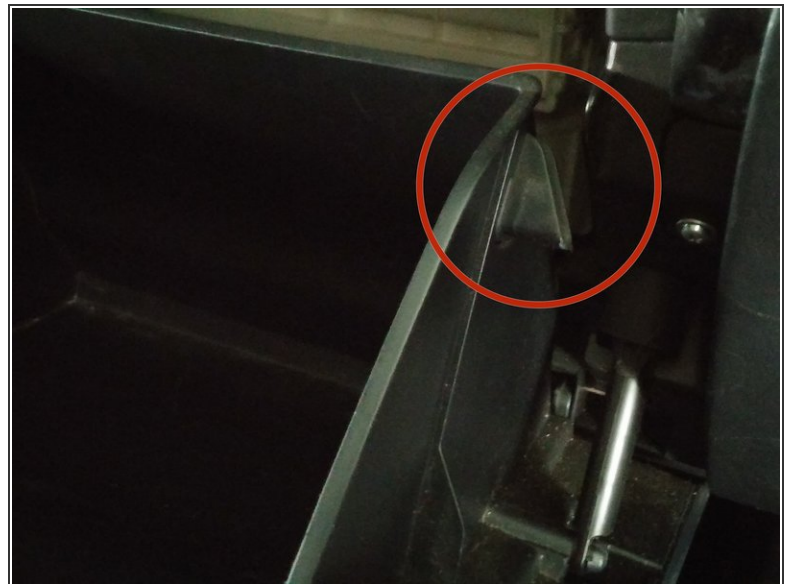
## Step 2

- Using both hands, apply inward pressure to the sides of the glove compartment until the compartment is free to slide out.
- The clips on the side of the glove compartment must be freed.

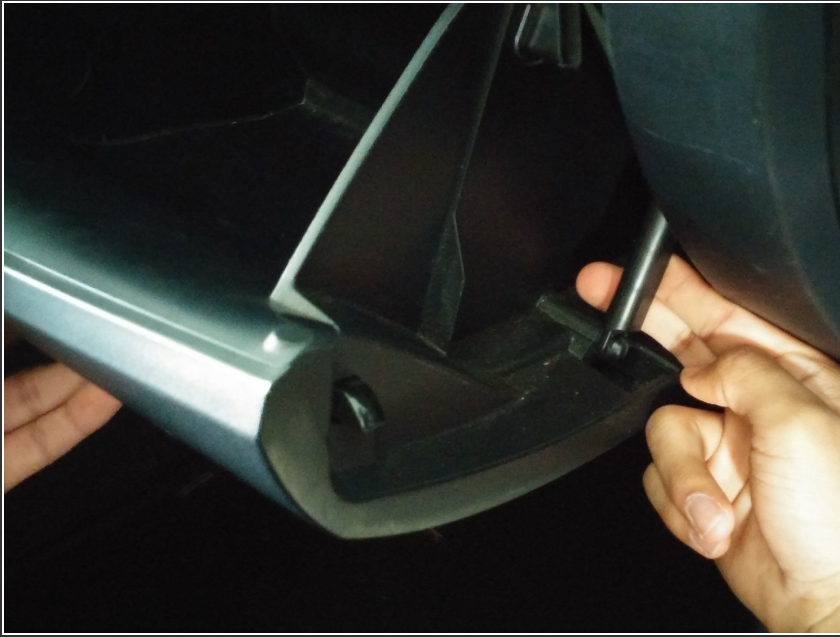
### Step 3

- Remove the attached plastic arm by simply pulling outward so that the arm snaps out of its socket.

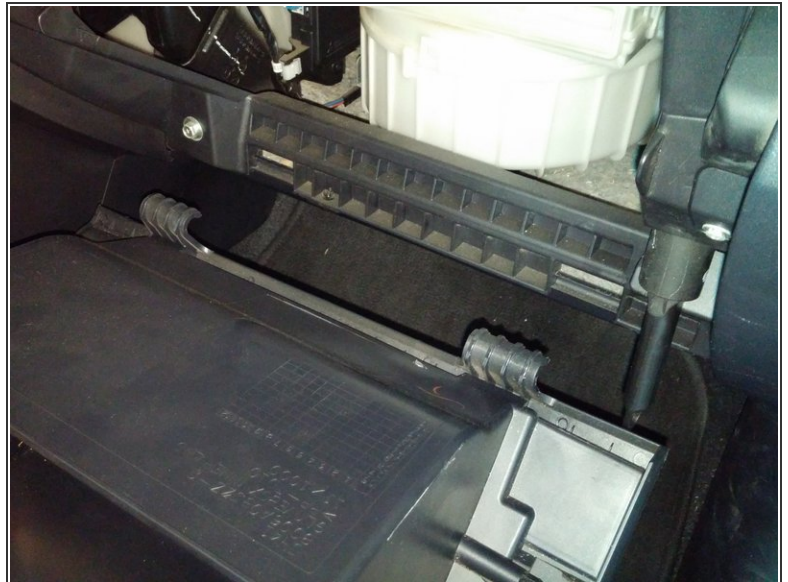
### Step 4

- The glove compartment can now be removed completely by raising it off its hinges.

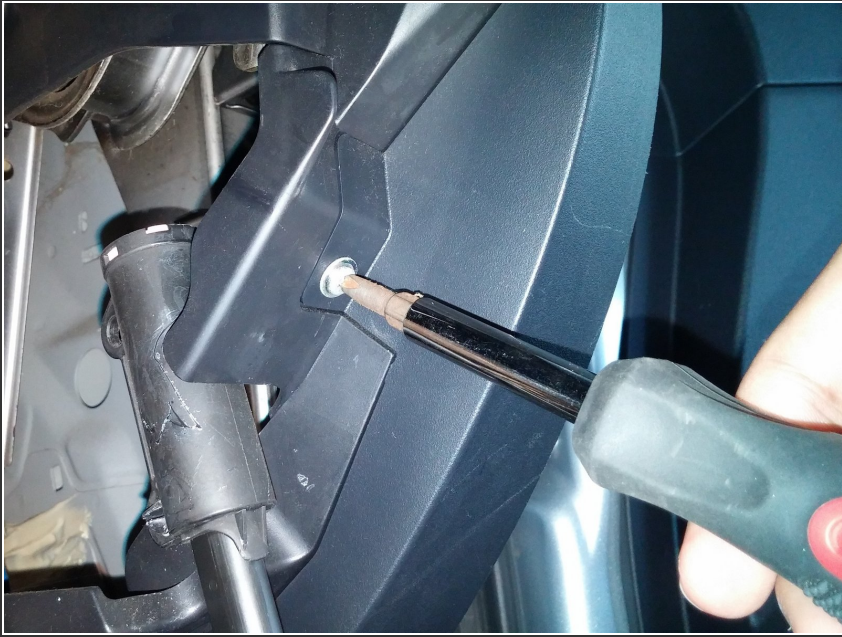
## Step 5

- Using the Philips #2 screwdriver, remove a 15 mm screw located just above the glove compartment damper piston.

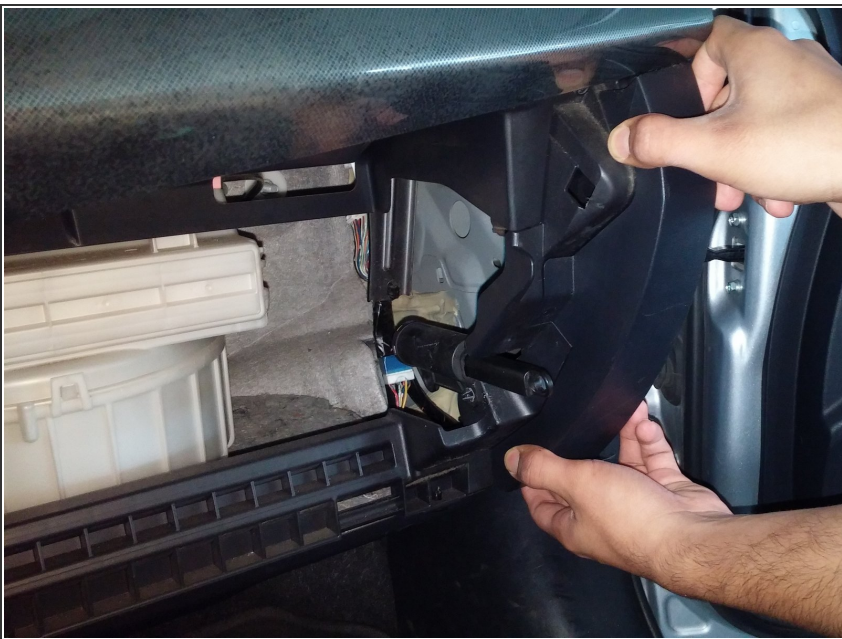
## Step 6

- Carefully remove the plastic trim by pulling outwards.

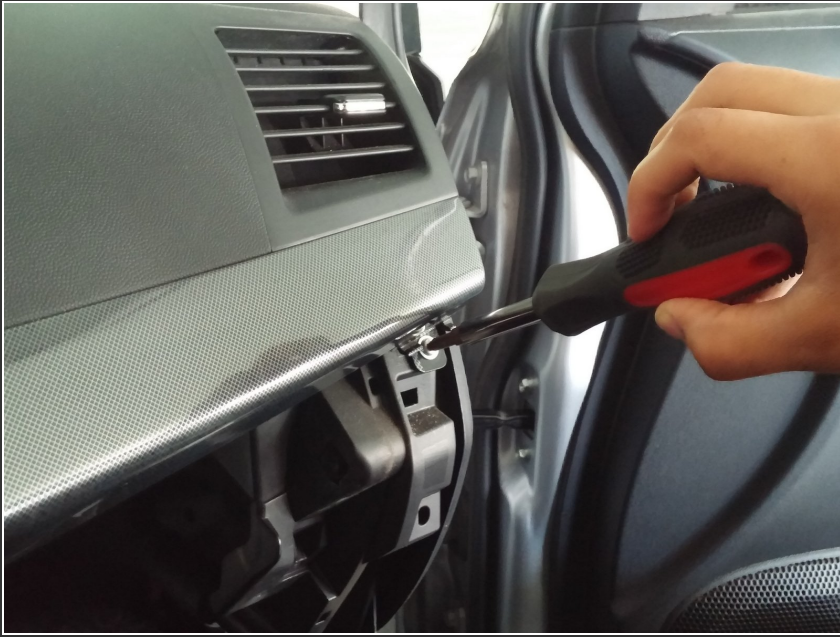
## Step 7

- Using a Philips #2 screwdriver remove a 15 mm screw from the trim piece.

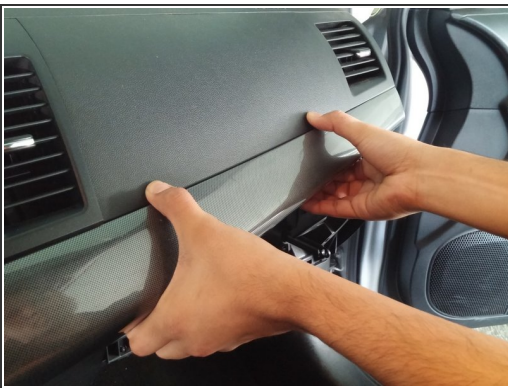
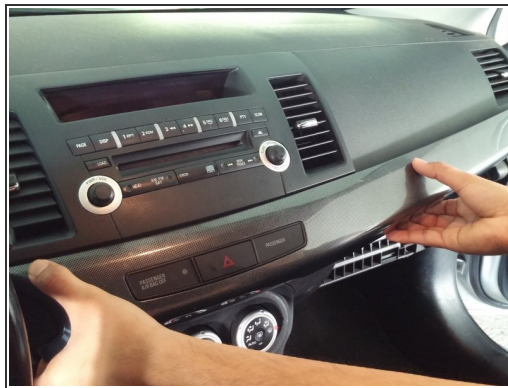
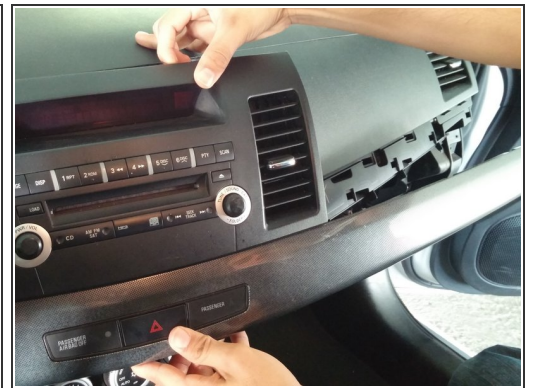
## Step 8

- Using both hands, carefully pull the trim outward section by section.
-

The dashboard and decorative trim are attached to each other, so they will come out as one unit.
-

When pulling out the trim start from the right and work your way toward the center console.
