Repairing Mitsubishi WS-65511 Blinking green light fuse replacement

Written By: oldturkey03

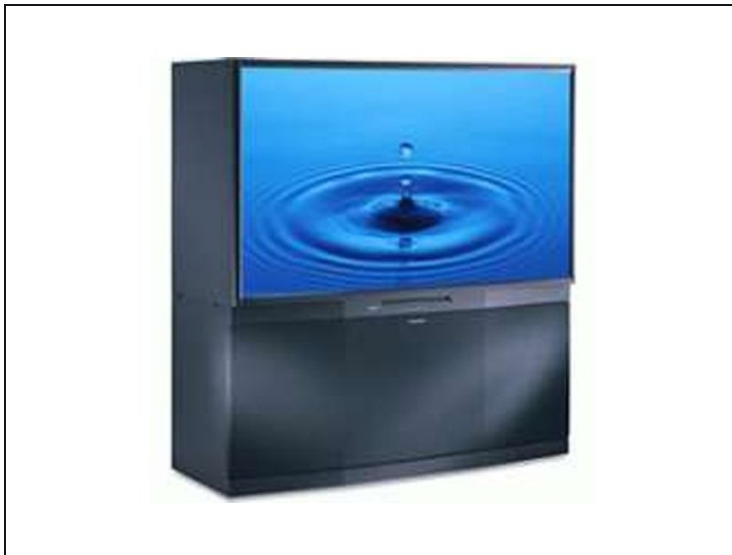
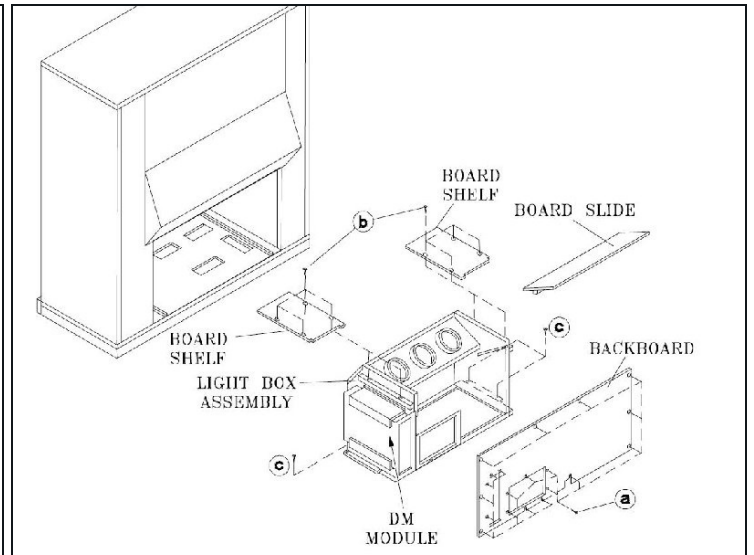
Step 1 — Repairing Mitsubishi WS-65511 Blinking green light fuse replacement

- Unplug the set. disconnect the coax cable and any other device plugged into the TV.
- Remove the back panel
- The antenna coax cable as well as other device connect directly to the DM module which is enclosed in a metal case.

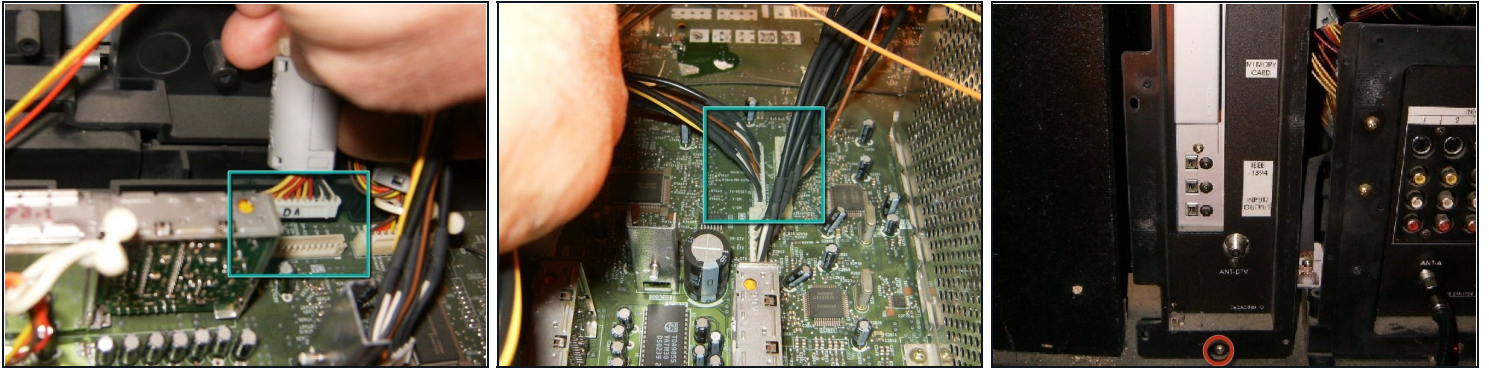
Step 2

- Disconnect the wiring coming off the DM board to the main chassis. On this TV there were four separate wiring harnesses: DA,VA,DB and PF. These markings are **not** of importance to this repair. But they all are clearly marked on the connectors as well as the logic board they connect to. This will help to identify their proper position for the re-assembly.
- Undo the two screws that hold the plastic cover to the DM board.

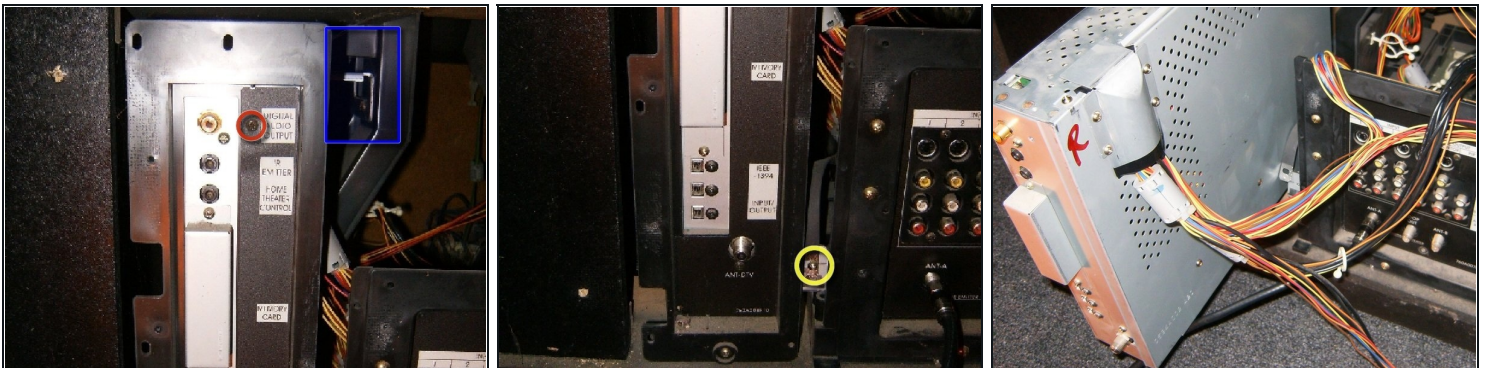
Step 3

- To the bottom right is a screw that connects a ground strap and holds the board to the chassis, undo that.
- With all the connector disconnected, the ground strap removed, pull the DM board carefully from the chassis. Some models have a small tab stop that you must push down to release the board.

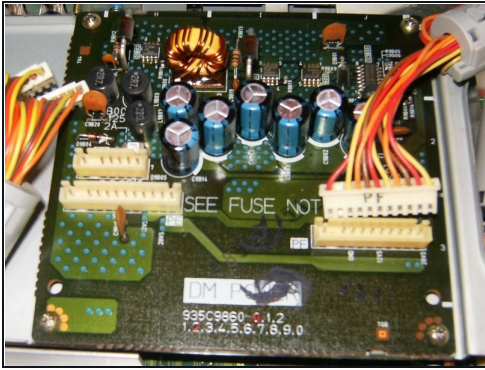
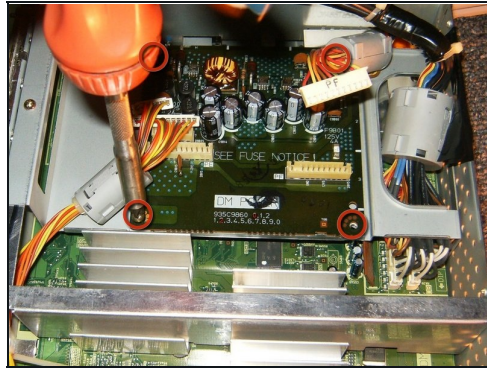
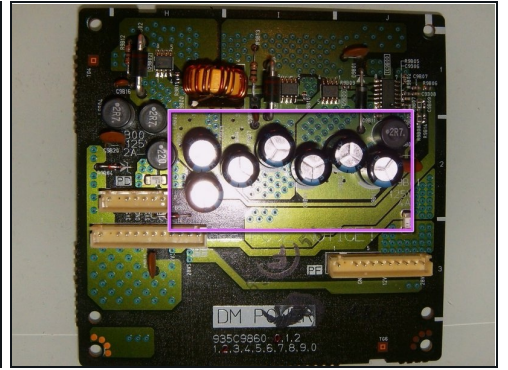
Step 4

- Remove the wiring attached to it (PD,PE,PF). These are simple connector and can just pulled of. These markings are **not** of importance to this repair. But they all are clearly marked on the connectors as well as the logic board they connect to. This will help to identify their proper position for the re-assembly.
- Remove the four screws holding the board on.
- This board has 7 1000uf 16Volt capacitors. These are the ones that have a tendency of failing. Inspect those for bulging tops as well as leakage. In this case, one capacitors was slightly bulged.

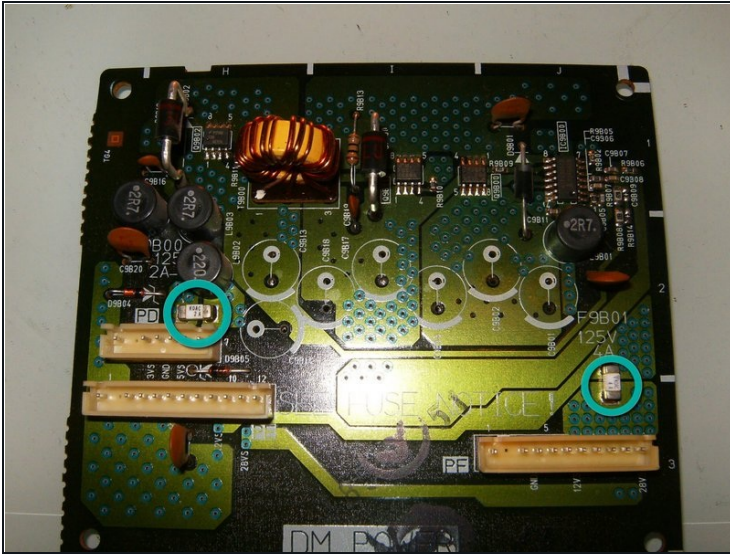
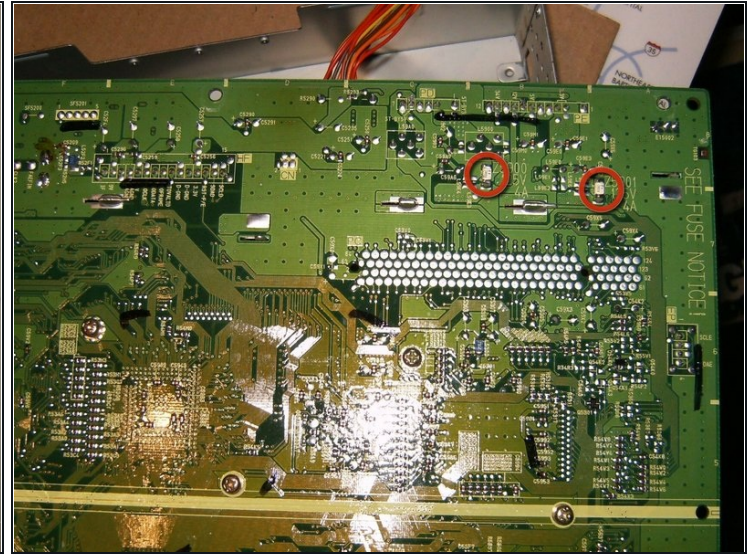
Step 6

- While the board and the DM power module are accessible check the SMD fuses for continuity. There are two on the daughter board. In this case, the fuses had continuity and were functioning.
- The main PCB has two fuses on the **underside**. In order to get to it, one will have to disassemble the module further. This was skipped in this repair.
