Saab 9-3 Ignition Switch Module (ISM) Replacement

How to replace the Ignition Switch Module (ISM) on a Saab 9-3 Aero 2007-2011, after "Steering lock Malfunction" error message

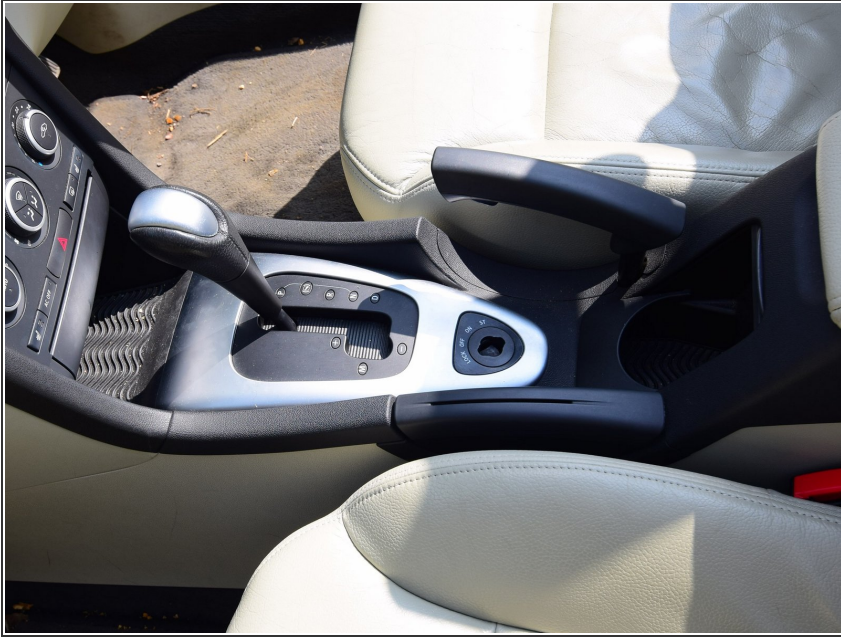
Step 1 — The starting point

- Our starting point: The center console with the ignition switch in the middle

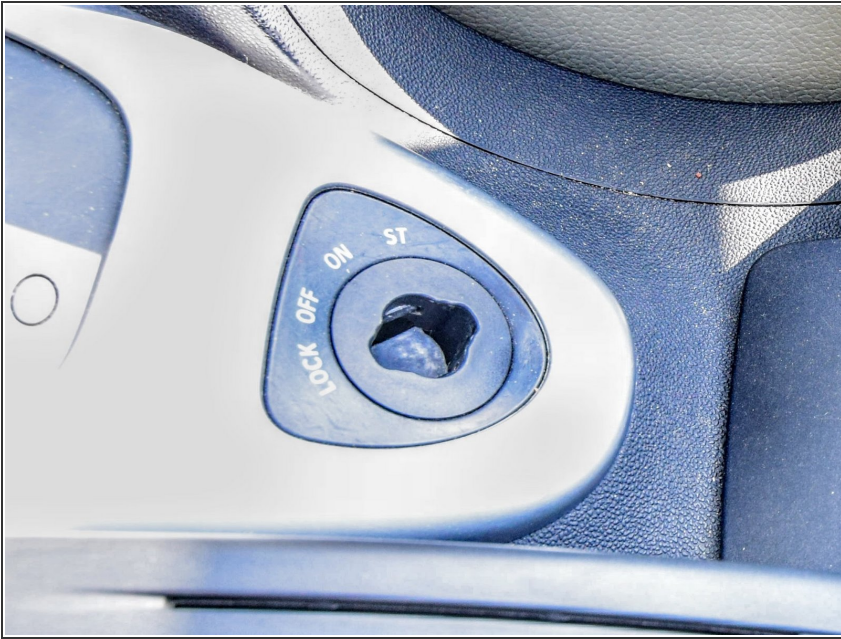
Step 3 — The ISM (Ignition Switch Module)

- This is the item we need to replace

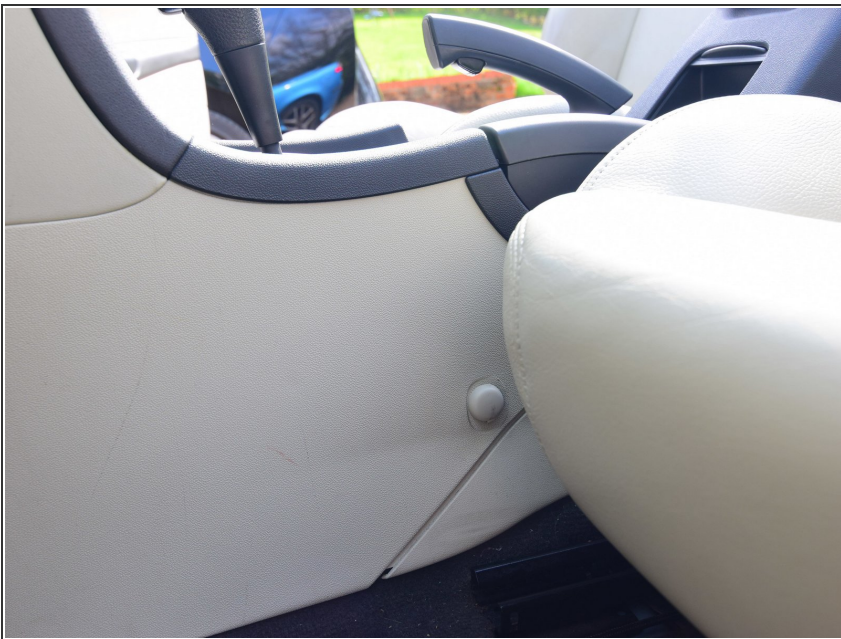
Step 4 — Front side panels

- Step one is to remove the front side panels. There is a single (covered) screw in the footwell on each side

that can be removed, and the panel slides rearwards, down and out.

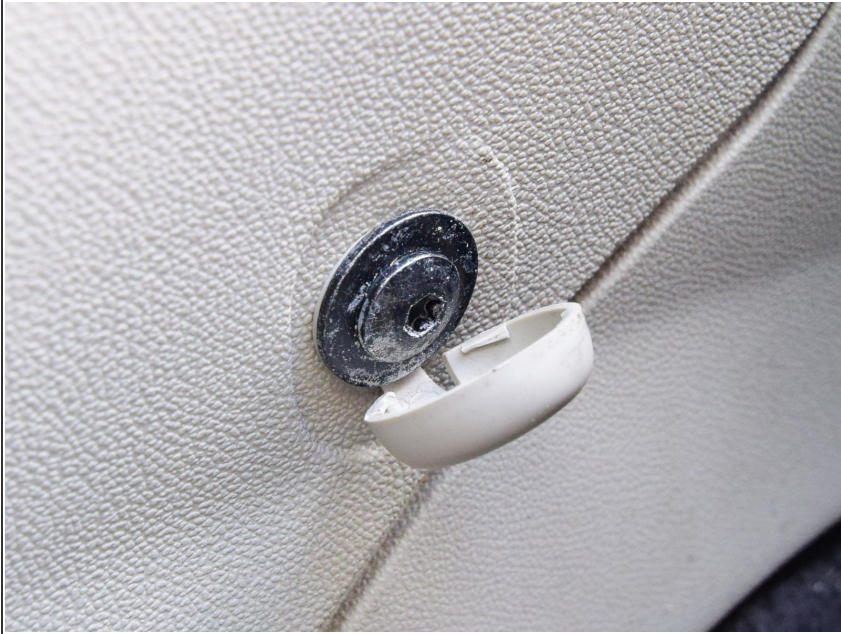
Step 5 — Panel screw

- Unscrew and remove this screw

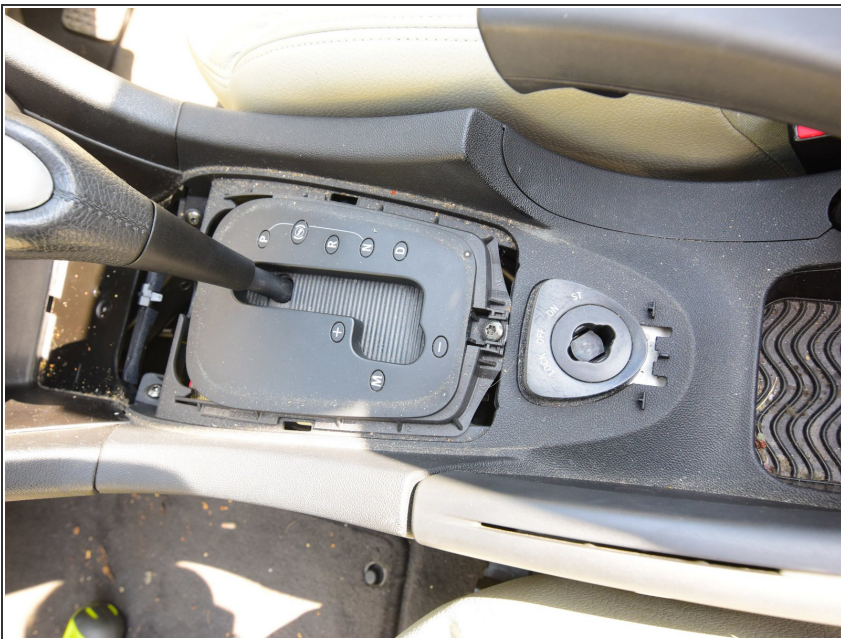
Step 12 — Retaining frame holding screw

- Removing the gear lever surround trim exposes a single screw holding a retaining frame underneath the gear change mechanism.

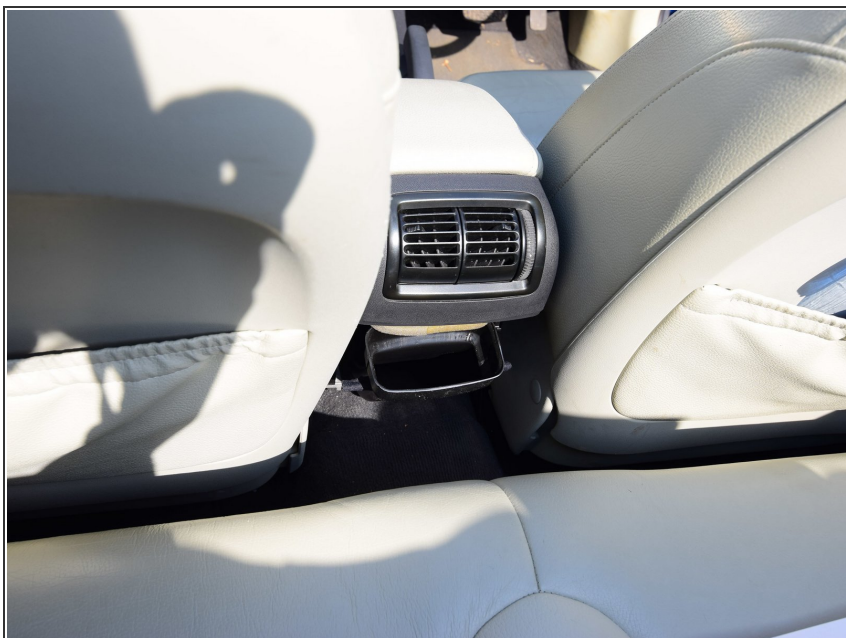
Step 24 — Air duct

- Underneath the air vent controlling air flow to the passengers from the center console sits a square duct.

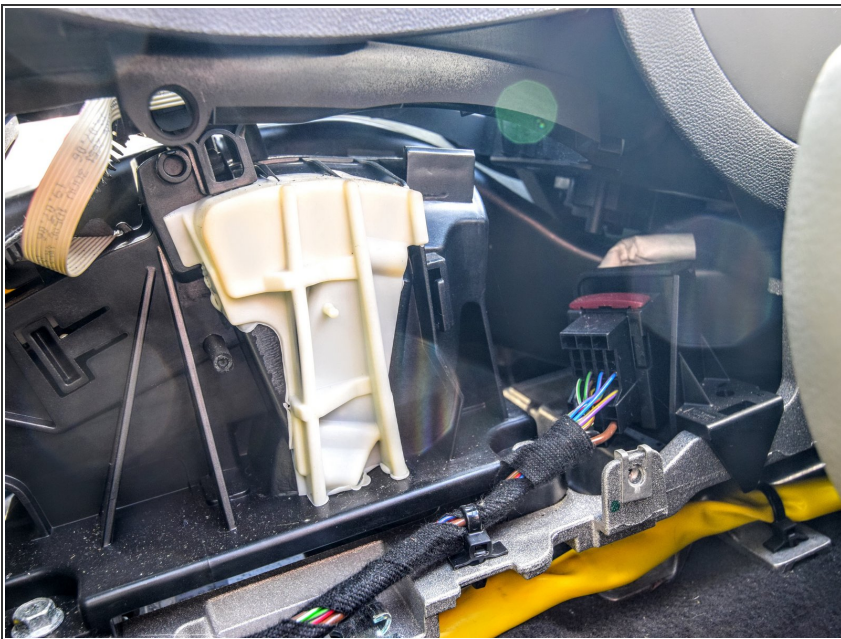
Step 26 — Cable bundles

- There are two cable bundles connected to the center console from the rest of the car. One is

connected via a large, square plug with a red tab.

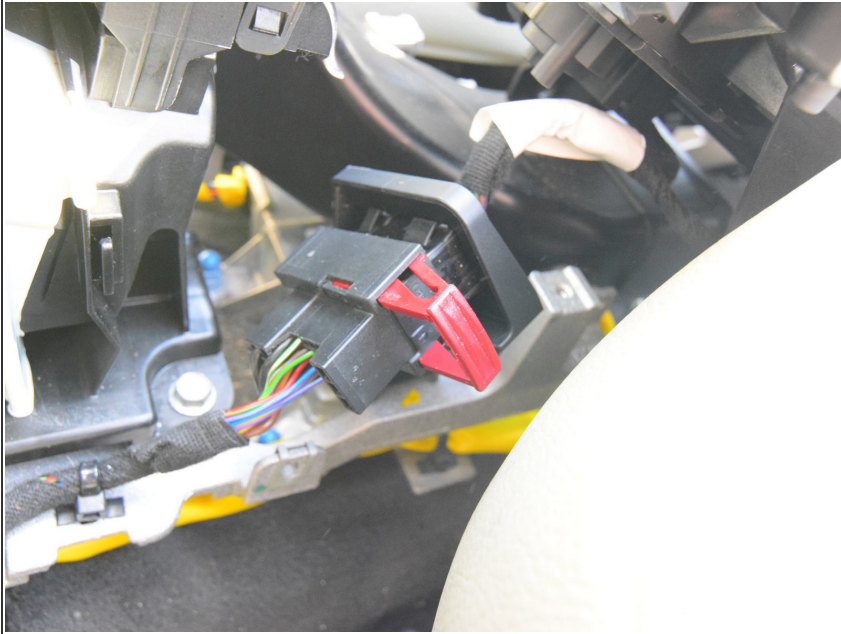
Step 27

- Push a screwdriver inside the red tab and pull, and the connector splits neatly apart.

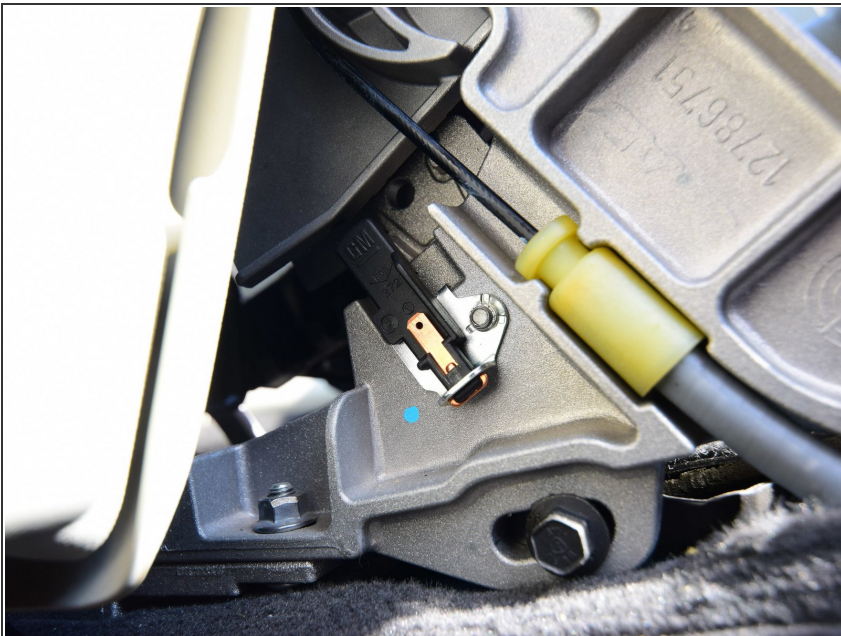
Step 28

- The other is an earth connector near the rear of the console. This can easily be pulled away.

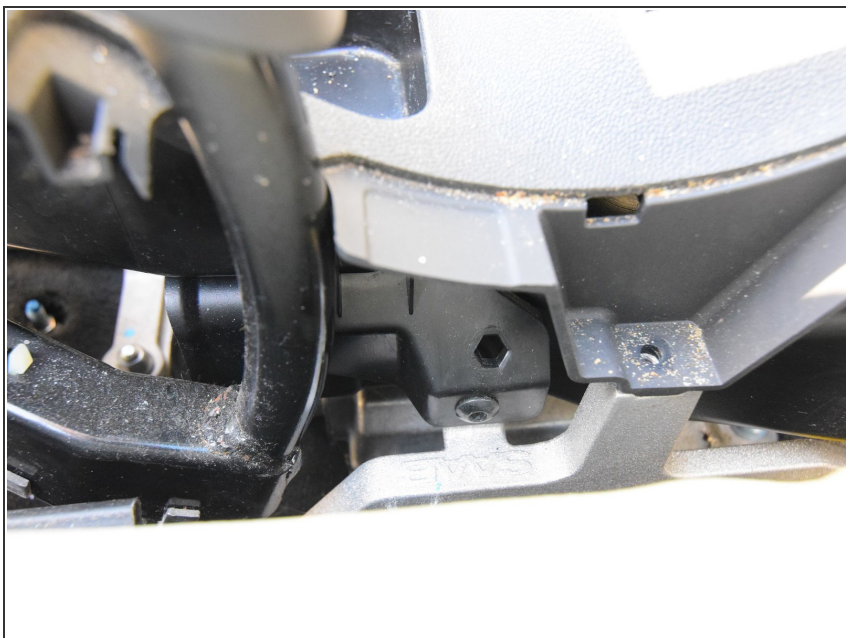
Step 30 — Horizontal retainer screws -- a fiddle to get out!!

- The next bit is a bit fiddly to get to: There are two screws going horizontally, one underneath the handbrake,

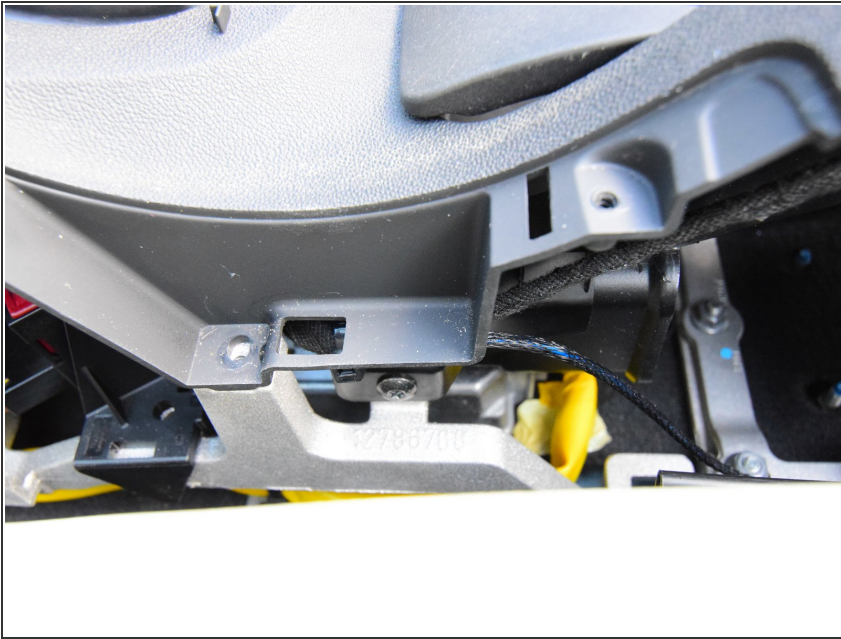
Step 31

- the other on the CD holder side. These need to be removed. There is limited workspace. Use a separate loose screwdriver bit, and a spanner to twist it.

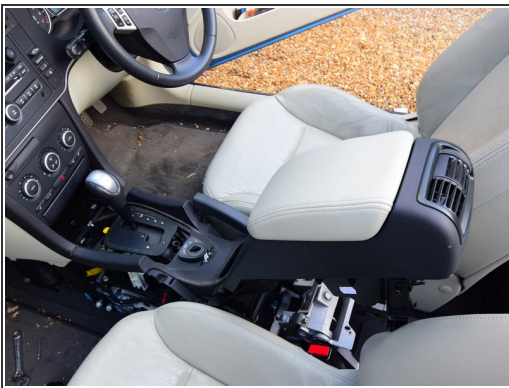
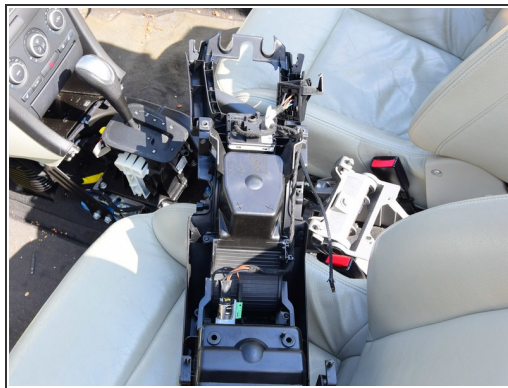
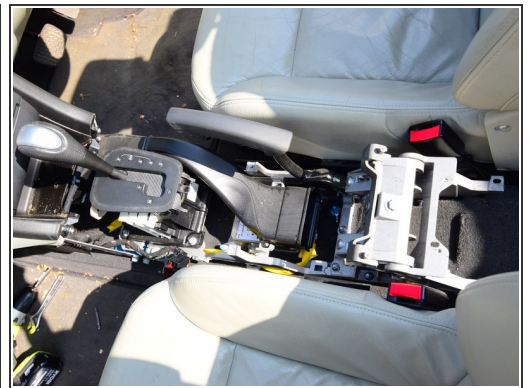
Step 32 — Remove center console

- The center console is now loose, and can be pulled backwards and upwards, and removed from the car.

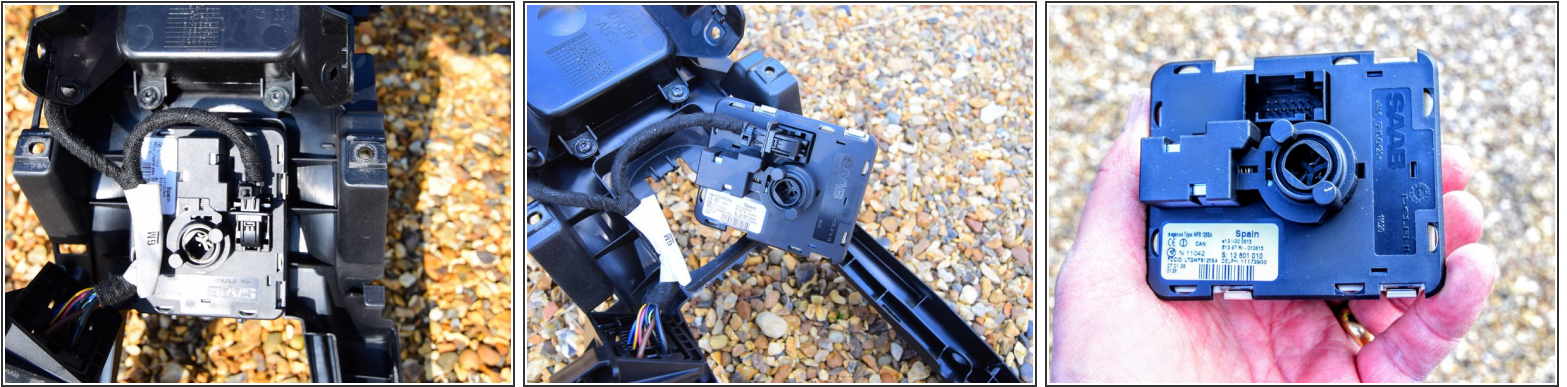
Step 33 — ISM switch

- Tip the centre console upside down and locate the ISM ignition switch. There are four spring clips holding it in place. Use a screwdriver to compress each clip in turn, whilst pushing the switch out of its socket.

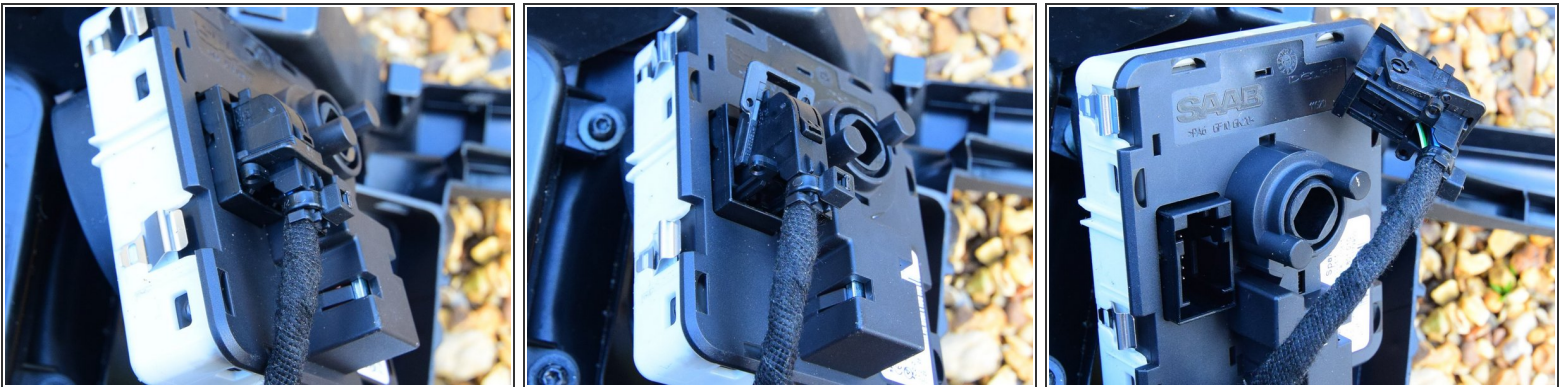
Step 34

- The switch is connected to a cable via a connector. Locate the torque lever and twist this to release the connector.

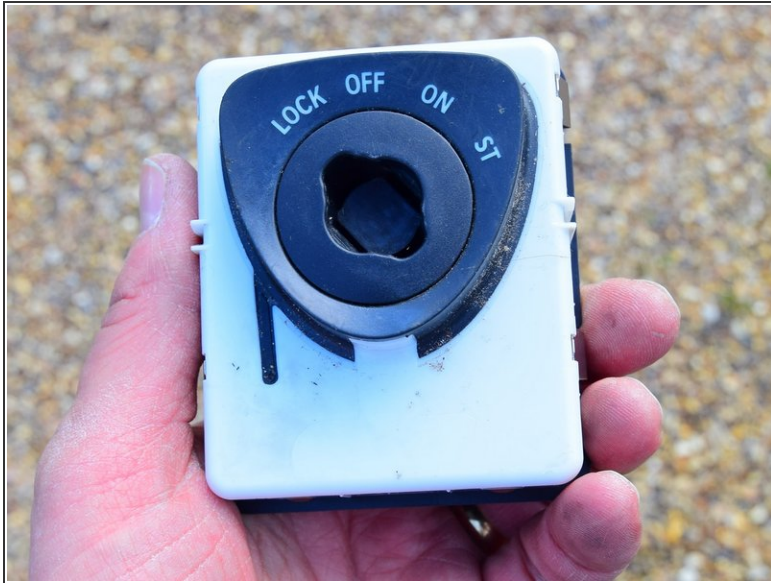
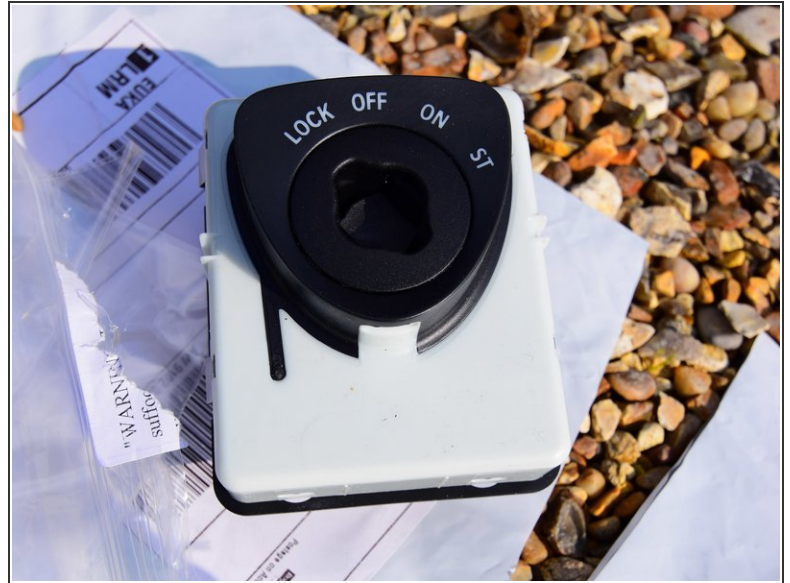
Step 35

- You now have the ISM in your hand. Swap this with a replacement unit. Mine cost £126,00 new from eBay. Clip it in the same spot, and connect the cable again.

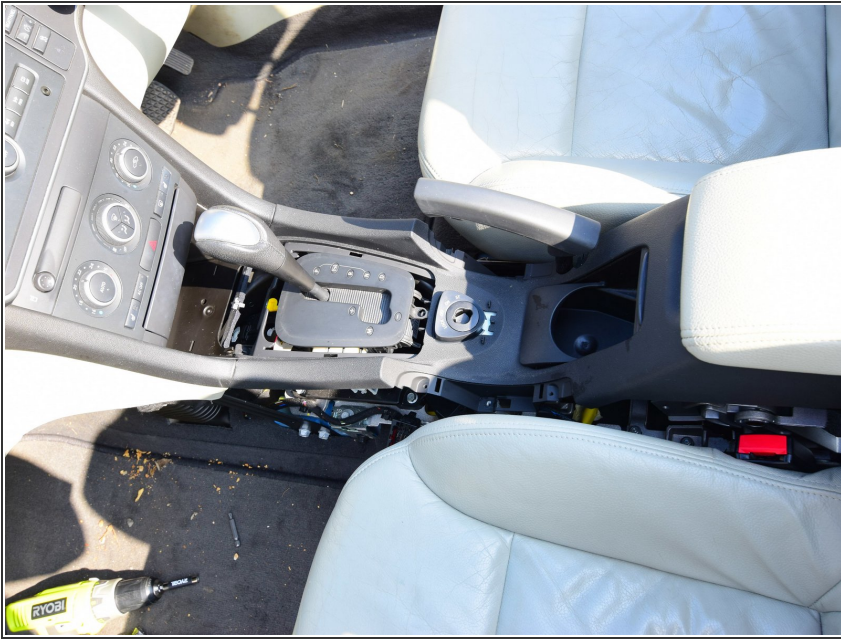
Step 37

- The square air conditioning duct goes in first. The console goes in next. It is a bit awkward to riggle past all the lugs, screws, tabs and cables, but just persevere. Once in, fit all the screws holding it in place, including the awkward ones.

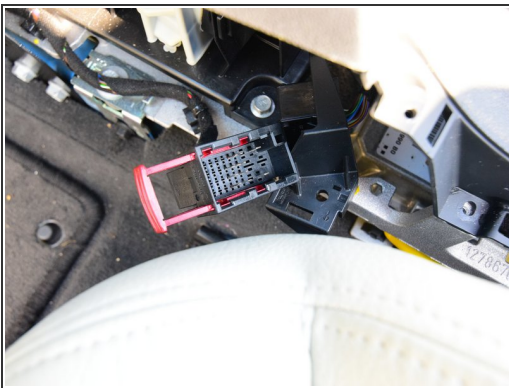
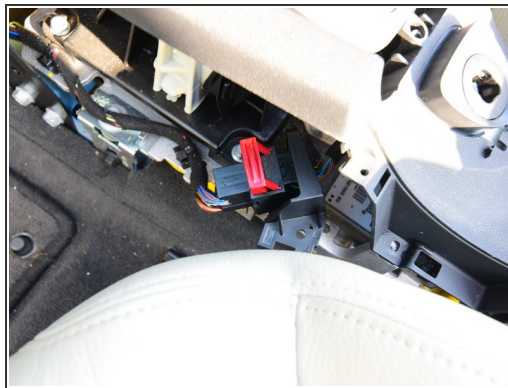
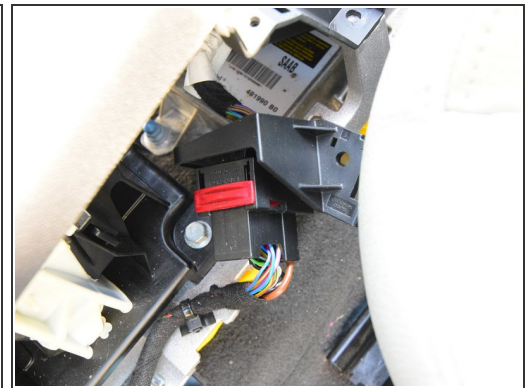
Step 38

- Connect the two cables. The earth connector is push-on, and the square plug self-locks when the red tab is pushed.
