Wolf Gourmet WGTR102S Slide Assist Plunger Replacement

Details how to replace the slide assist plunger for the Wolf Gourmet WGTR102S Toaster.

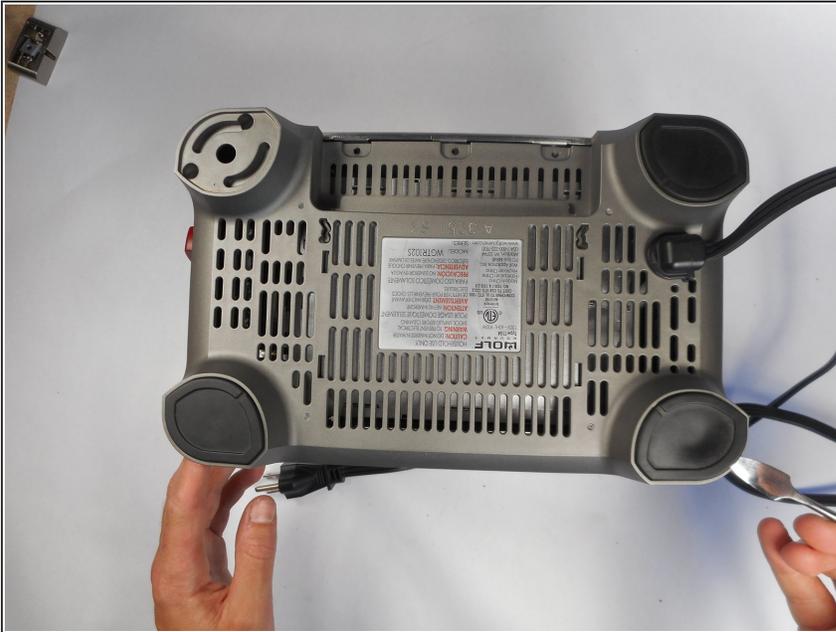
Step 1 — Outer Shell

- Using a wedge, pry off the rubber pieces on the bottom of each foot of the toaster.

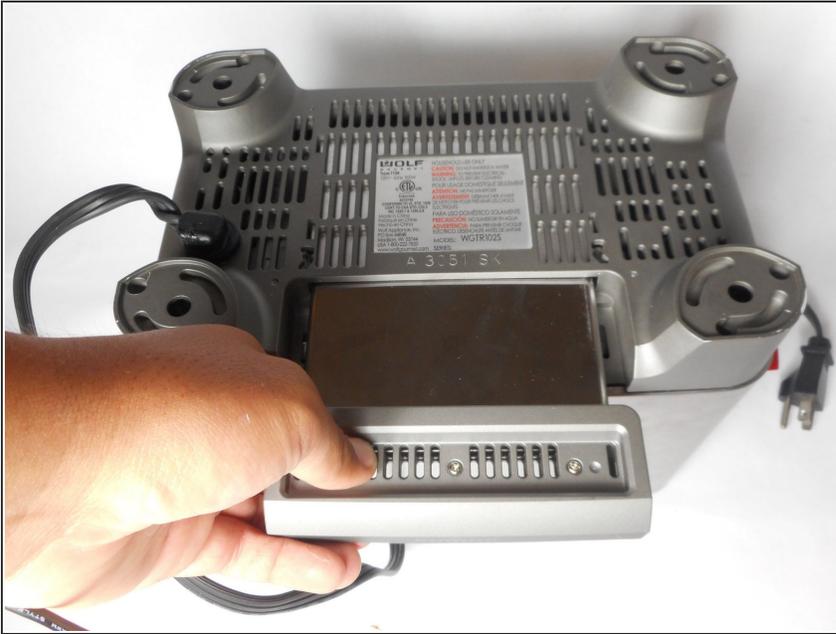
Step 3

- Remove the crumb collector located on the bottom of the toaster.

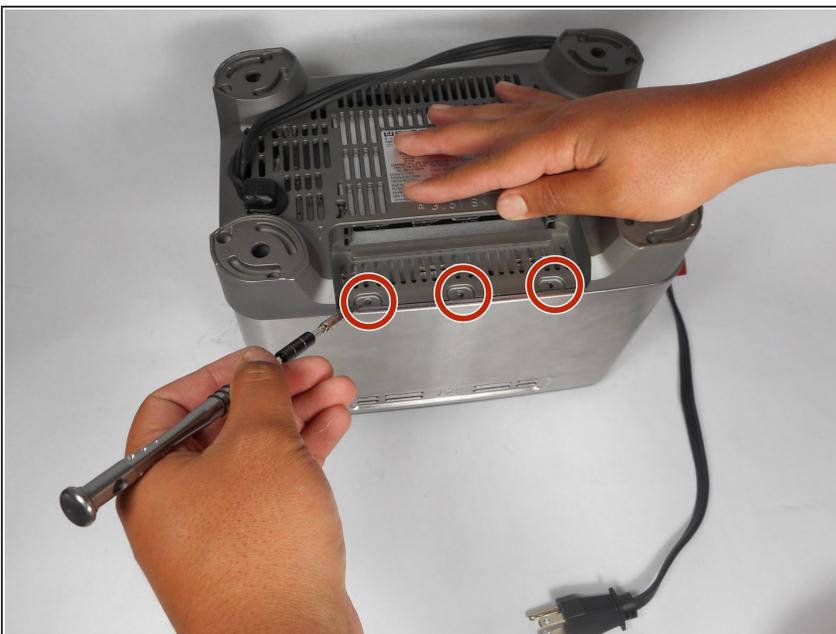
Step 4

- Remove the three 8mm screws using the Tri-point Y1 screwdriver.

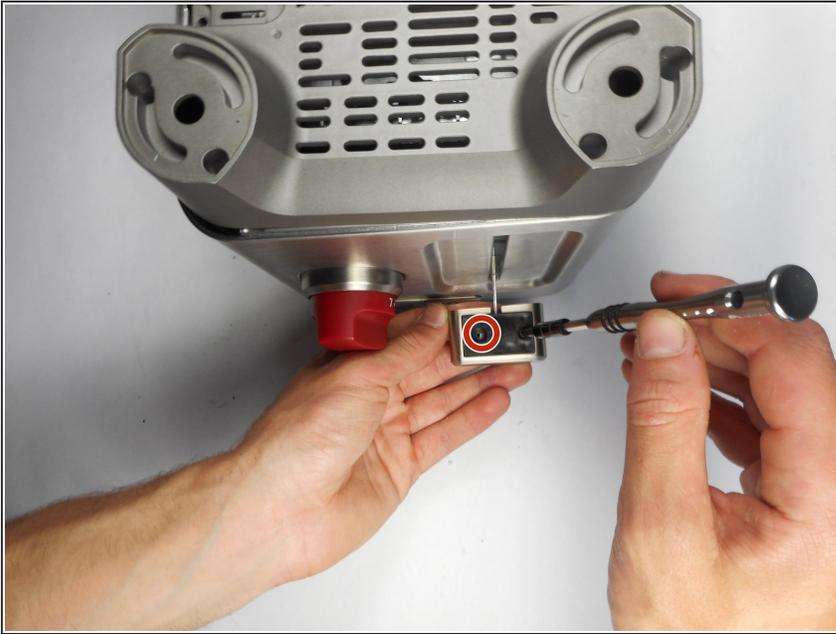
Step 5

- Remove the two 8mm screws on the bottom of the slide lever using a Tri-point Y1 screwdriver.
- Once the screws are removed, detach the black plastic cover on the bottom of the slide lever.

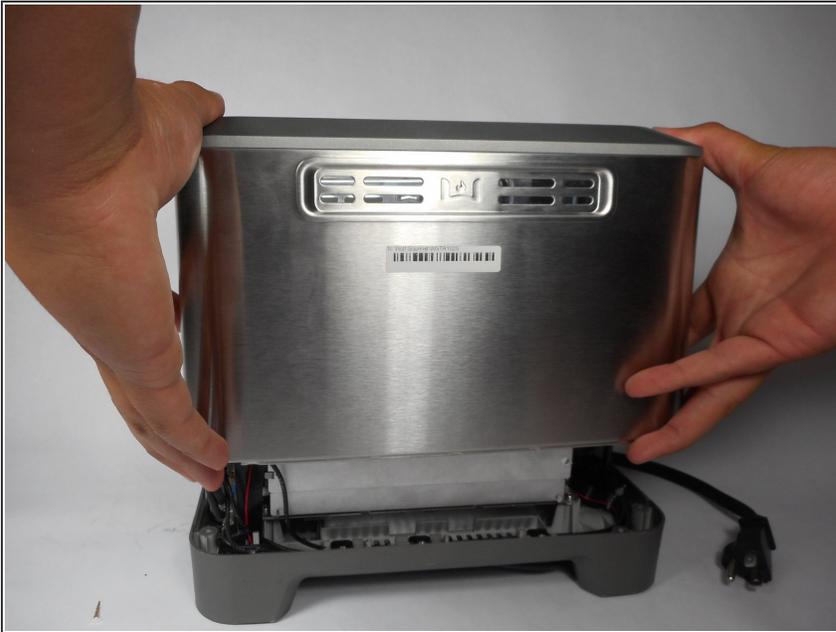
Step 7

- Remove toaster's outer shell by lifting straight up.

Slowly remove the outer shell. Disconnect ground wire before fully separating the shell and inner components.

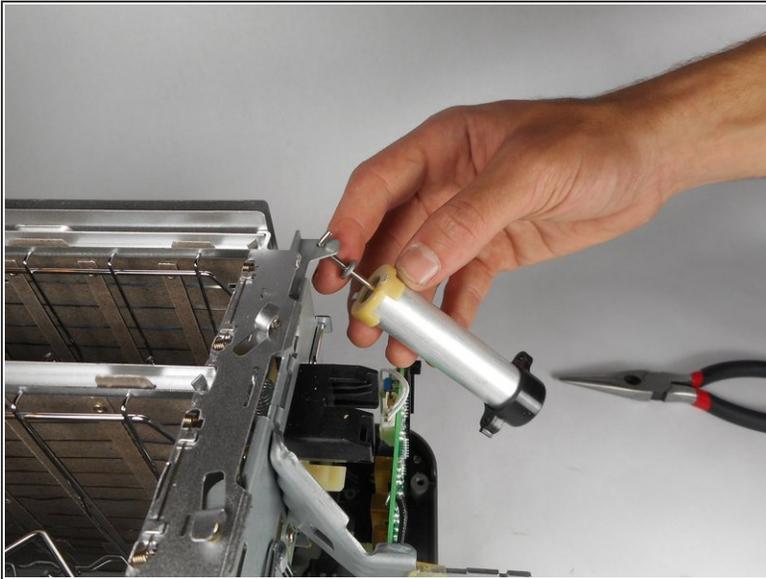
Step 11

- Remove the plunger from the device.

To reassemble your device, follow these instructions in reverse order.
