# Huawei Mate 30 Pro Teardown

An iFixit teardown of the Huawei Mate 30 Pro, in which we discover its fancy new vibration motor and humongous battery.

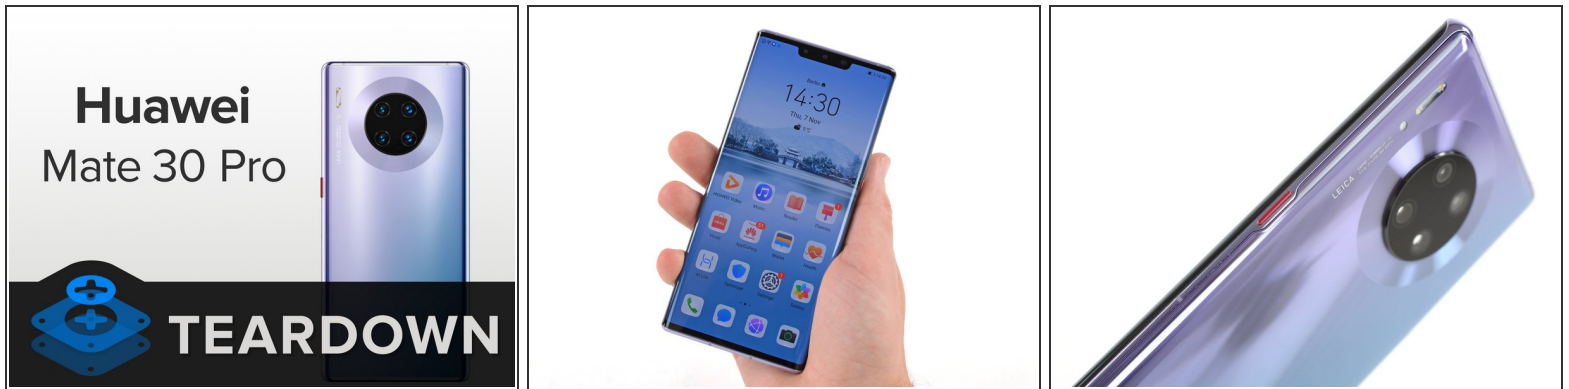
## Step 1 — Huawei Mate 30 Pro Teardown

- It may look like a front-load washing machine, but cleaning your laundry is about the only thing this phone *can't* do. Check out the specs on our teardown unit (Chinese model LIO-AL00):
  - 6.53" OLED display with a resolution of 2400 × 1176 (~409.29 ppi)
  - Huawei Kirin 990 processor with 8-core CPU, 16-Core Mali-G76 GPU, and Neural Processing Unit
  - *Quadruple* rear cameras—40 MP *f*/1.8, 40 MP *f*/1.6, 8 MP *f*/2.4 with 3x optical zoom, and a 3D depth-sensing camera
  - 32 MP *f*/2.0 selfie cam, plus a 3D depth-sensing camera
  - IP68 dust/water ingress rating, USB-C port (but no headphone jack)
  - Facial recognition hardware, gesture recognition, and an under-display fingerprint sensor

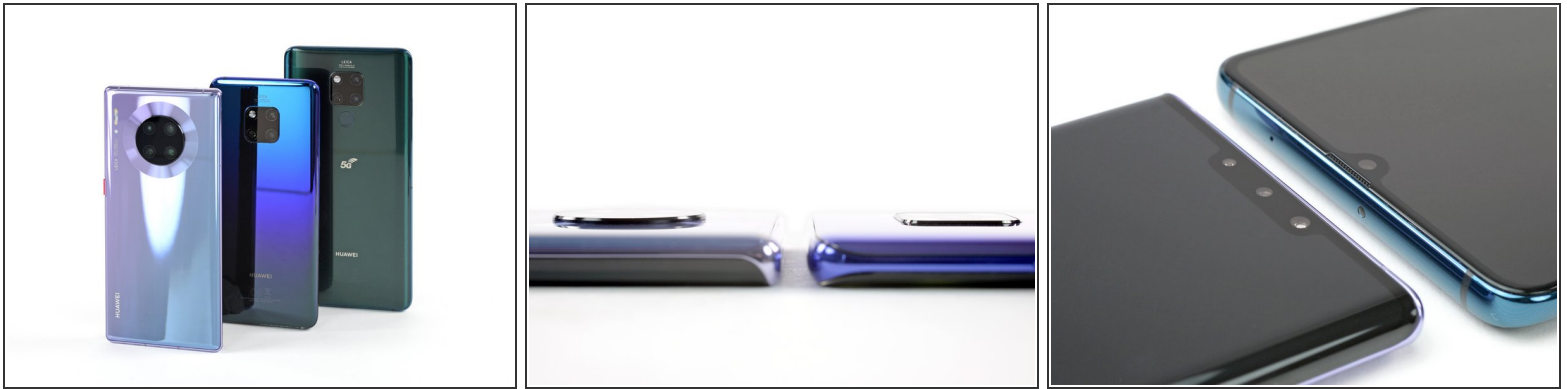
## Step 2

- In a size comparison, the gigantic Mate 20 X 5G still dwarfs the rest of the Mate lineup, including our Mate 30 Pro.
- But at 1.1 mm tall, the 30 Pro's camera bump is more than double that of the 0.4 mm bump on last year's vanilla 20 Pro.

- Meanwhile, the 88° "ultra curved" display makes for a sleek-looking device, and will make you fumble for a good hold on the slick back.
- ❗ It also ships with a bumper containing cutouts on the sides for some [smooth volume control](#)—potentially hampering its bumper function, and maybe even obscuring the [Quad-Finger Game Control](#).

- We're curious about how those display curves look from the inside. Historically, we've found that curved displays are a [big pain](#) to remove.
- At the upper edge of the screen, the Mate 30 Pro's additional 3D depth-sensing camera also takes a lot more space than the camera in the tiny teardrop notch of its predecessor.

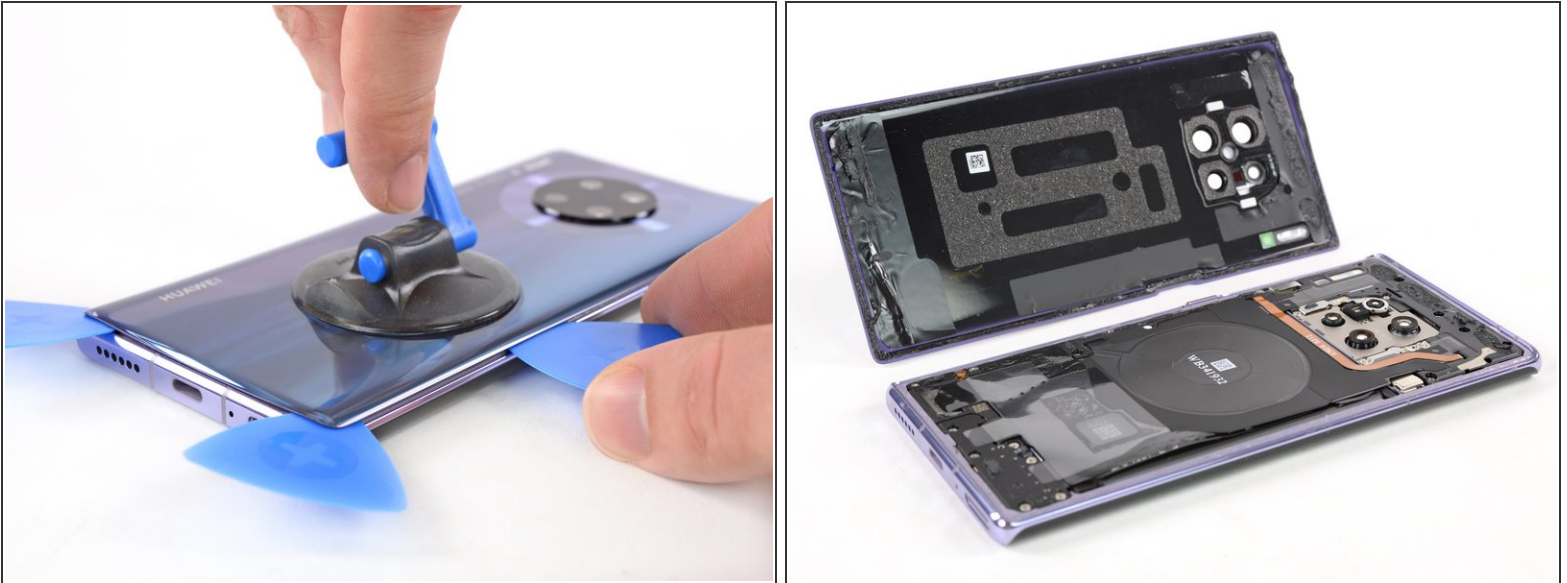
## Step 3

- As interesting as the display is, we're pretty sure it has to come off last. Instead, we attack the back cover with our classic move: [heat-lift-slice](#).
- ⓘ Since the fingerprint sensor sits under the display, we shouldn't encounter any boobytrap cables here—except for perhaps the camera flash ...
- We make it through unscathed! The back cover lifts off cleanly (with some gentle convincing). Everything peeking through the back cover while this thing is sealed up is either mounted in the plastic camera frame, or safely housed in the camera module—no booby trap cables here.

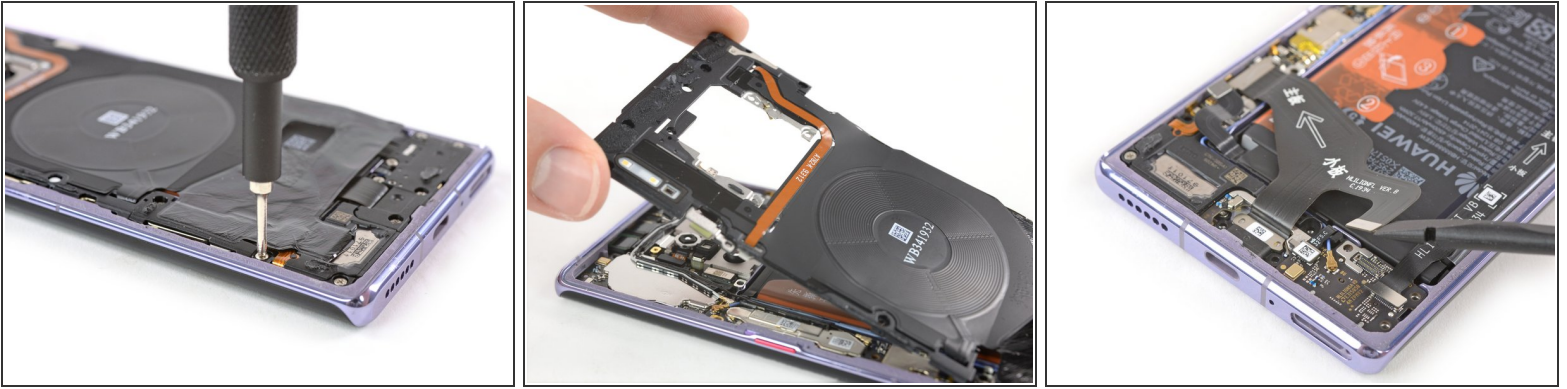
## Step 4

- With just a few flicks and swishes with our [precision bit driver](#), we remove the classic plastic combo frame: flash, NFC coil, and a wireless charging coil.
- With the frame out of the way, we extract a sprawling Y-shaped interconnect cable that ... interconnects the USB-C port, motherboard, and accessory board together. It has a handy arrow in case the electrons get lost and need directions.

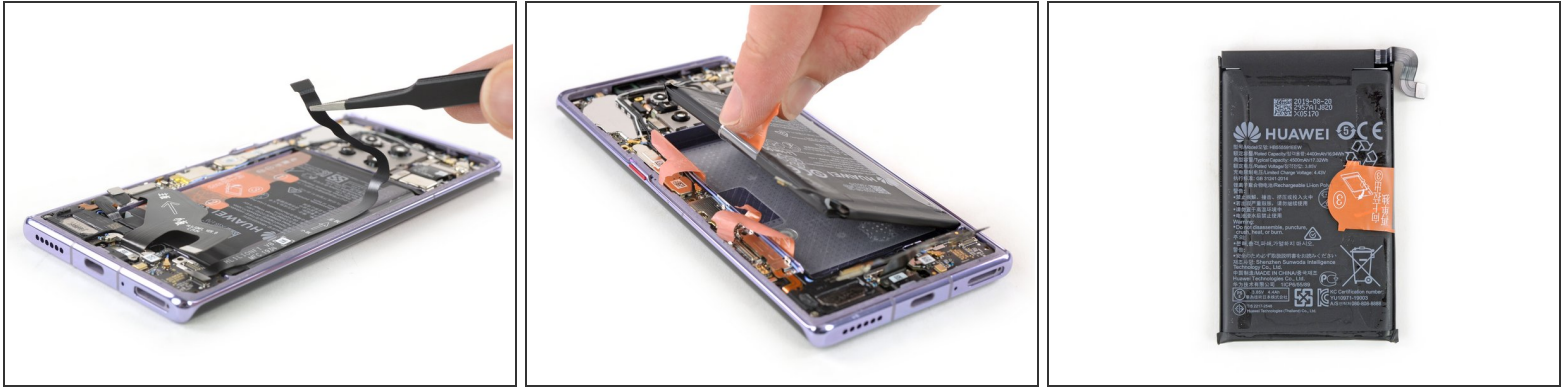
## Step 5

- The only other thing between us and the battery is this anaconda of a cable ("snakes on a phone," anyone?)
  - ⓘ While fiddly, we prefer these easy-to-access interconnect cables over cables hidden under the battery ripe for [accidentally prying through](#).
- This battery comes out with familiar rip-and-pull tabs—or is it pull-and-rip? Whatever it is, it's orange, and it has instructions on it—better than [nothing](#), though.
- The 4500 mAh cell is rated at 3.85 V, and a whopping 17.32 Wh of total power. That's a bit more than the 16.04 Wh from the [Mate 20 X Pro](#) or [the P30 Pro](#). The iPhone 11 Pro Max trails behind at [15.04 Wh](#).

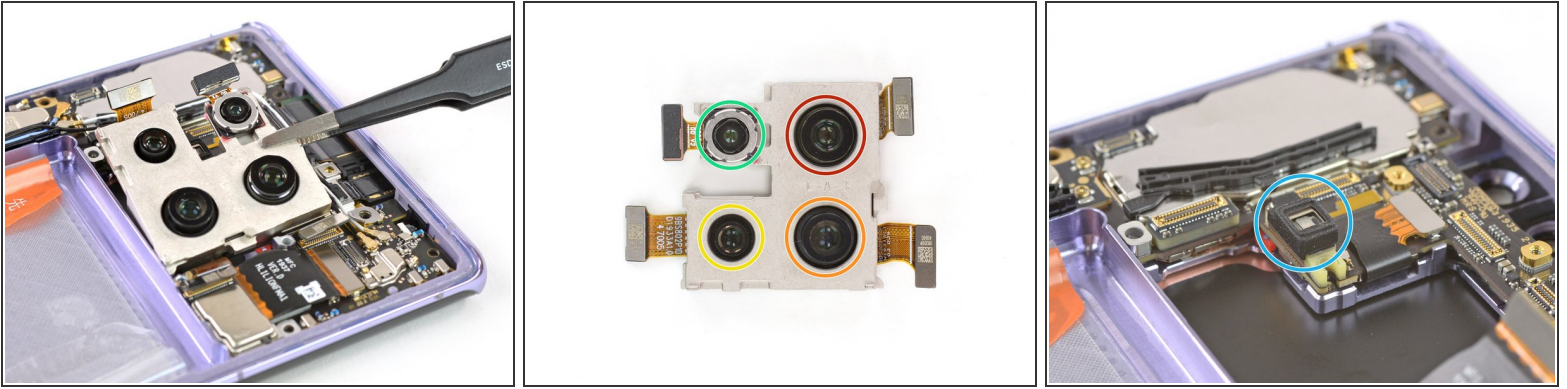
## Step 6

- These four lenses are the horses for Huawei's marketing carriage—and with good reason. It's quite a lineup:
  - 40 MP  $f/1.8$  Cine Camera with a classical RGGB pattern on a  $1/1.54''$  IMX608 sensor, outputting a 3:2 format

- 40 MP  $f/1.6$  SuperSensing Camera with Huawei's special RYYB pattern and OIS on a  $1/1.7''$  IMX600 sensor, shooting in 4:3
    - ⓘ This camera can supposedly shoot [256x Ultra Slow-motion videos @7680 FPS](#), which might explain [this little breakout board](#) sitting in the middle of the data stream from the SuperSensing Camera. Is it a dedicated ISP (Image Signal Processor) for intensive slo-mo image buffering and calculation?

- 8 MP  $f/2.4$  telephoto lens with OIS over an OV08A10 sensor to offer 3x optical zoom, 5x hybrid zoom and up to 30x digital zoom
  - 3D depth-sensing camera for real-time in-depth video effects with an [IMX316 sensor](#)

- What remains on the motherboard seems to be the dot projector module that gives the 3D camera something to look at.

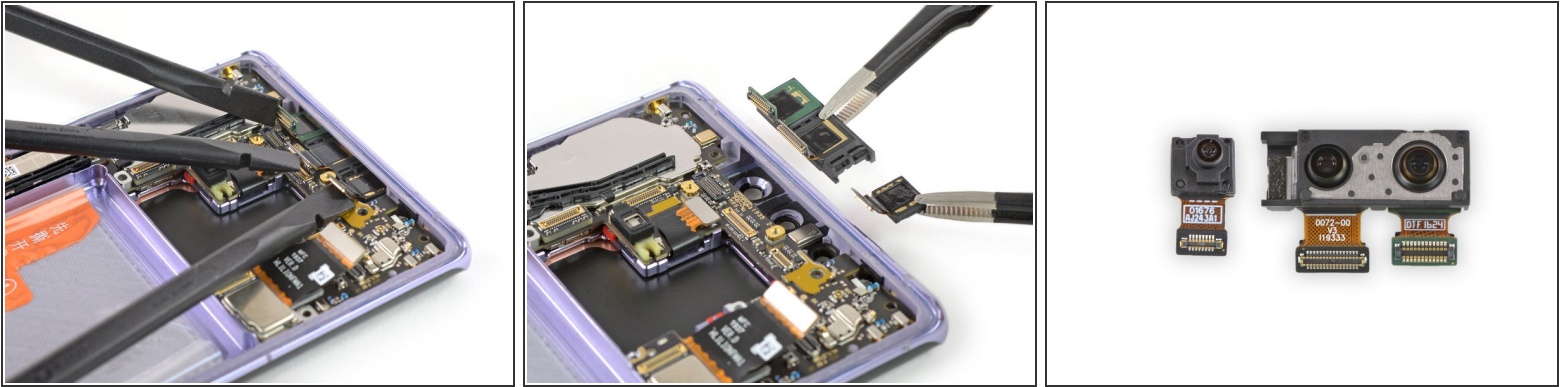
## Step 7

- A tenacious tandem teardown team effort spudges up the front-facing camera connectors to free three front-facing peepers.
- We momentarily scratch our heads as we wonder why Huawei only listed two front cameras in the [spec sheet](#), until we realize that one of these must be the *gesture sensor* mentioned elsewhere on the page.
- The double-wide camera couple houses the larger 32 MP  $f/2.0$  selfie cam on the right, (1/2.8" IMX616 sensor) and the aforementioned 2.4 MP gesture camera on the left (1/6.95" IMX332 sensor).
- The single unit is the 3D depth sensing camera with an IMX516 sensor—likely used for face unlock and depth effects for your selfies.

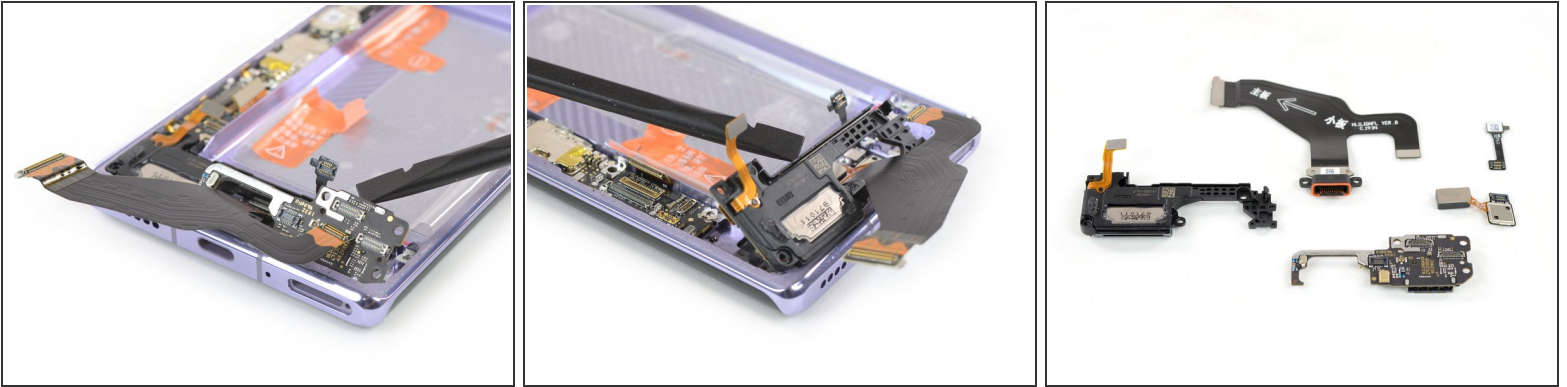
## Step 8

- With the cameras out of the way, we remember that this phone is more than just its seven cameras! There's a lot of other stuff in here:
  - The USB-C port and its Y-shaped interconnect cable
  - A daughterboard with the SIM card slot on the back
  - The loudspeaker in its plastic frame
  - The optical fingerprint scanner (SYNAPTICS S3909).
- ❗ What do all these parts have in common? They're modular and independently replaceable!
- At the north end of the phone, we're left with a bunch of writhing [snakes](#) coax cables.

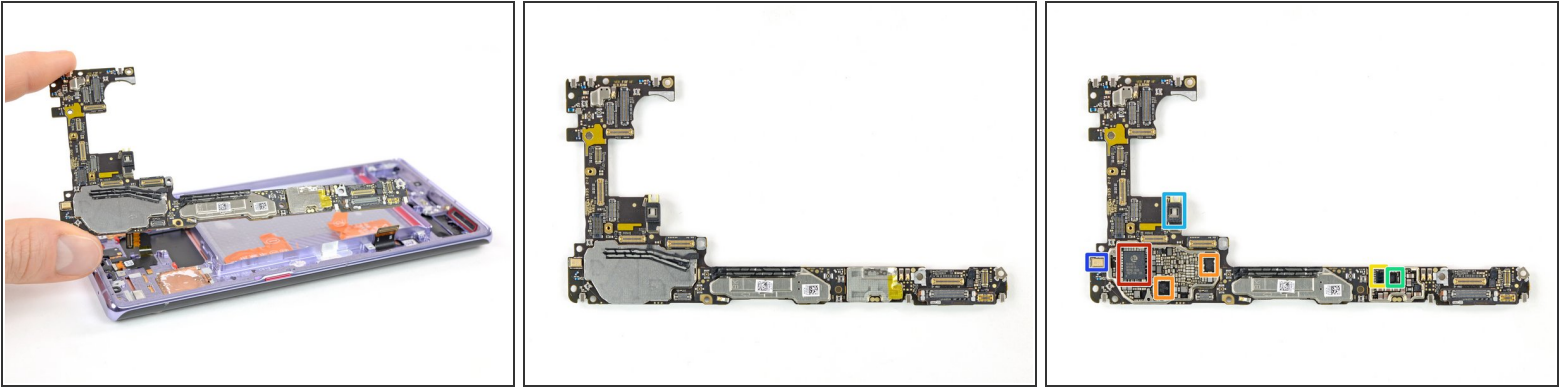
## Step 9

- With all those things crammed into the phone, the motherboard is shaped to fill the remaining space. Let's see what goodies we can find on this chocolate silicon bar:

- HiSilicon Hi6421 power management IC
- HiSilicon Hi6422 power management IC
- STMicroelectronics BWL68 wireless charging receiver IC
- Halo Micro HL1506F1 battery management IC
- Dot projector
- Microphone

- ① Beneath the motherboard, we spot a copper plate running down the left of the frame. This is similar to the Mate 20 X 5G's [liquid cooling system](#).

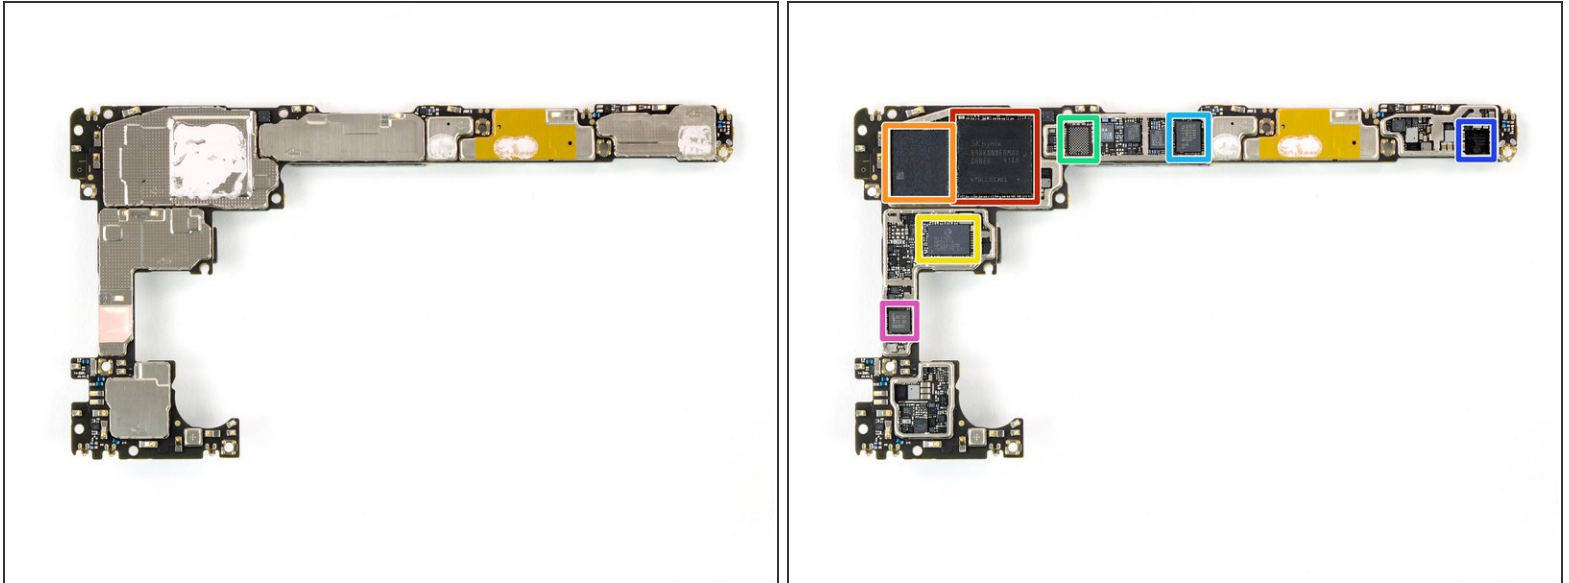
## Step 10

- The other side reveals:
  - SKhynix H9HKNNNFBMAU-DRNEH 8 GB LPDDR4X SDRAM with the SoC Kirin 990 layered underneath
  - Kioxia (Toshiba) M-CT041930U544311JPN 256 GB UFS
  - HiSilicon Hi1103 Wi-Fi module ([as seen in the Mate 20 X 5G](#))
  - An empty pad, which apparently hosts an [additional front-end module](#) in the 5G version of this phone
  - HiSilicon Hi6363 RF transceiver ([as in the Mate 20 Pro](#))
  - HiSilicon Hi6526 power management IC
  - NXP 80T37 (likely NFC controller)

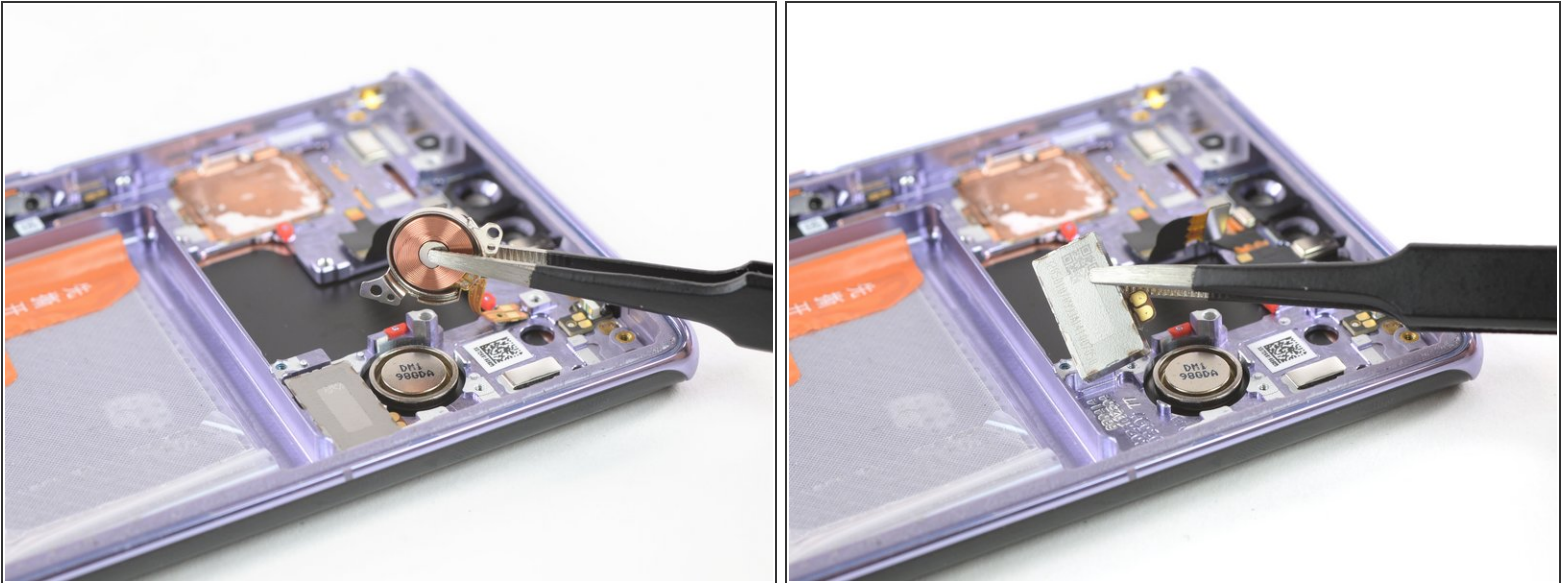
## Step 11

- Next we dig out the structure-borne speaker driver, previously seen in the [P30 Pro teardown](#).
  - ⓘ This little thing vibrates the display to create sound—replacing the traditional earpiece speaker we see in [other phones](#). It's a nifty trick, but not without some downsides: it's an additional component to replace with the display, and if you crack your screen around the driver, you'll likely see a drop in sound fidelity.
- Aaand what do we have here? It looks like the tiny circular LRA vibration motor from [Mates past](#) has been upgraded to a rectangular [taptic engine](#)-style buzzer.

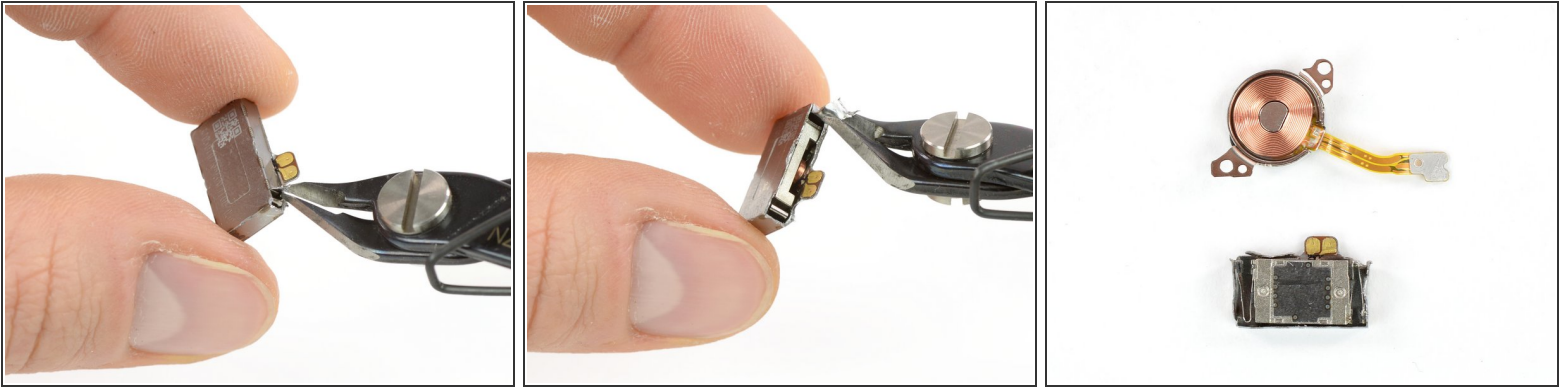
## Step 12

- Peeling the mysterious wobble box open like a can of sardines, we indeed find an x-axis linear actuator.
- What [Apple started](#) all the way back in [2014](#) seems to finally be catching on with other manufacturers. From [Meizu](#) to [Google](#) to [Samsung](#), and now Huawei—everyone seems to agree that precision haptics (and bigger motors) positively affect the way we interact with these pocket computers.

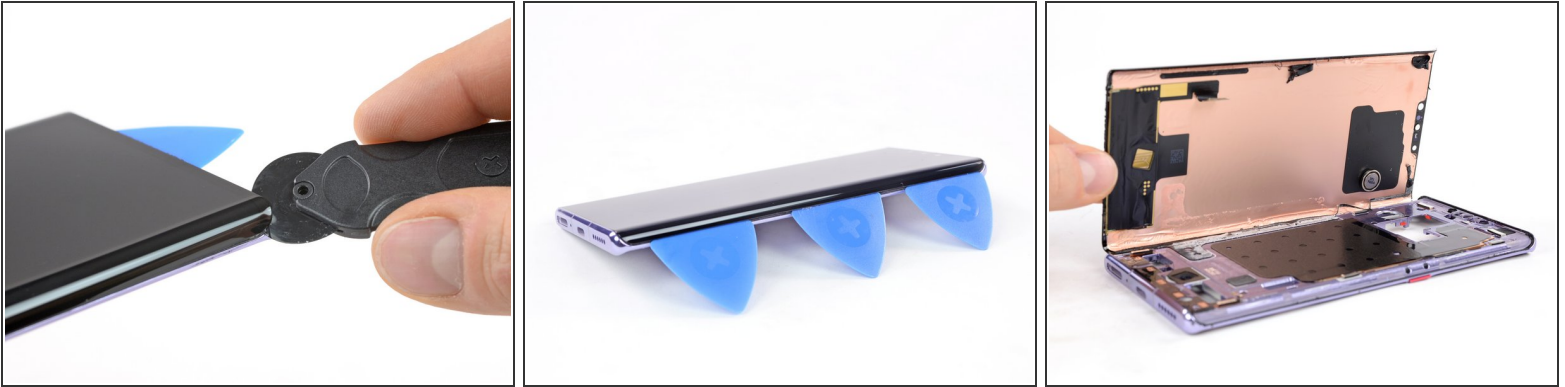
## Step 13

- Next up, the *ultra-curved* screen! We are faced with [zero margin](#) between the display and the frame.
- Patient heating and prying gets our foot in the seam, and we go slicing around corners and curves with our handy ~~pizza-cutter~~ [iMac Opening Wheel](#) that seems to be tailored for this job.
- Finally our opening picks can start gnawing on the glue behind the edge ...
- ... and eventually grant us the success we deserve—an open display.
- ① This display hooks up via a single, rather small connector. Many contemporaries have two separate plugs for the digitizer and the screen.

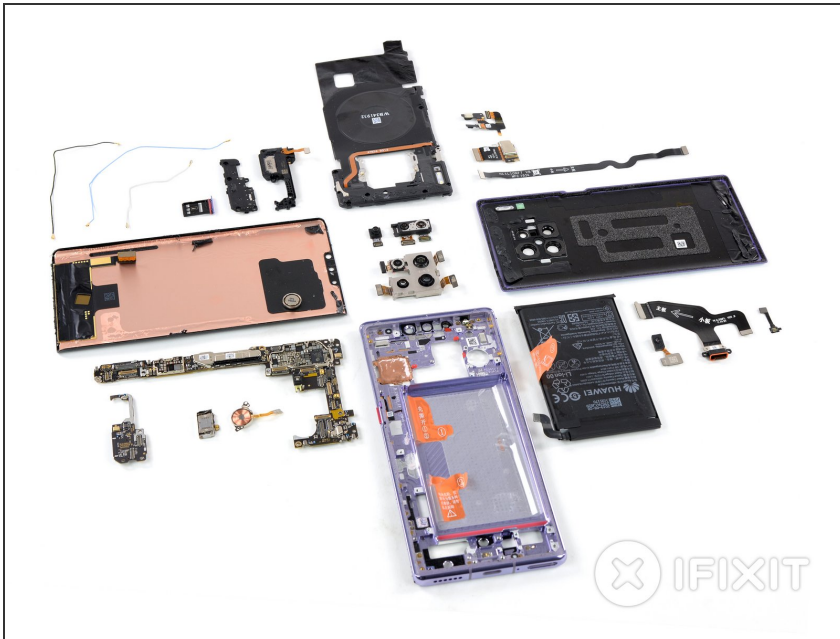
## Step 14

- This phone is chock full of modular components and cutting-edge tech. For once, we can sort of understand why they didn't make room for a headphone jack. (We'll probably continue to gripe about that though.)
- With that, here's a summation of our repairability findings.
