# Oster 6329 Bread Grabber Spring Replacement

This guide will walk you through replacing the spring that closes the toaster carriage.

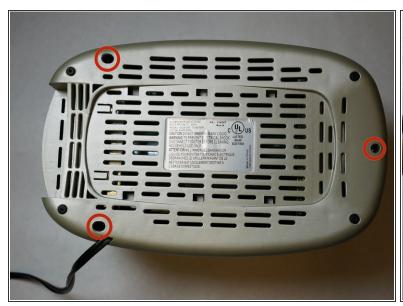
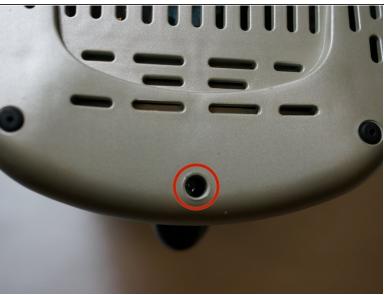
# Step 1 — Outer Shell Removal

• Using the Phillips-head #2 screwdriver, unscrew the three 1cm Phillips-head screws on the plastic base of the toaster to separate the outer metal shell from the plastic base.

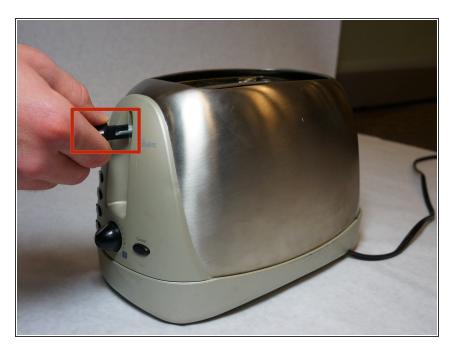
# Step 2

Push the plastic push-down handle down and pull the plastic handle straight from metal arm.

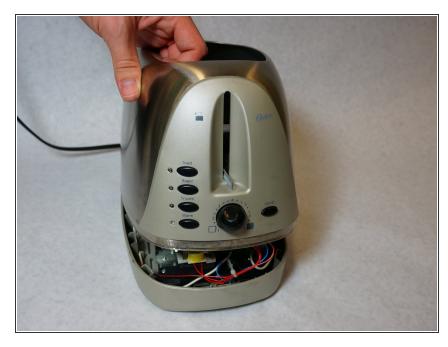
- Loosen the outer metal shell from the plastic base by holding the plastic base while pulling up on the metal shell.
- Only lift the outer shell a little so as not to disconnect the cables that connect the circuit board.

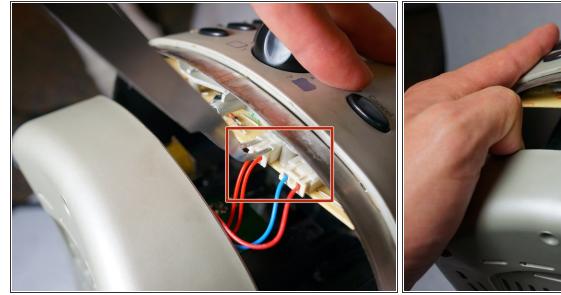
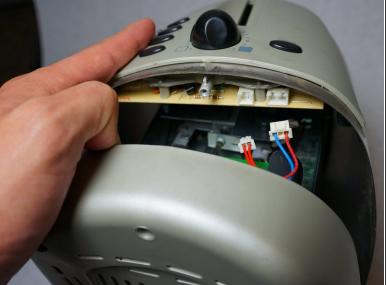
#### Step 4

Disconnect the cable clips from the circuit board using the tweezers to free the outer metal shell from the plastic base.

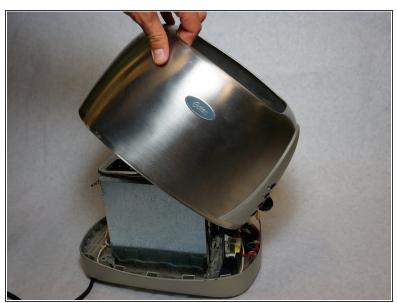
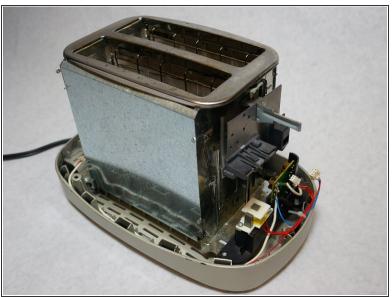
Lift the top outer metal shell.

Carefully lift the outer metal shell at an angle so as not to damage the components in the front of the toaster.

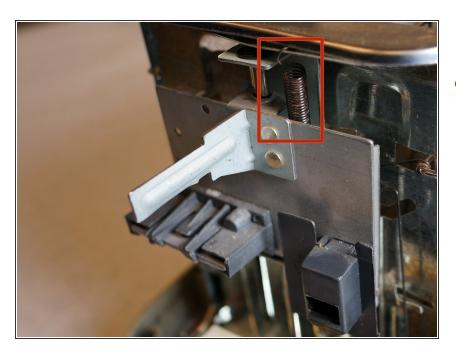
### Step 6 — Bread Grabber Spring

Press down on the toaster handle to access to the grabber spring located behind the large metal plate.

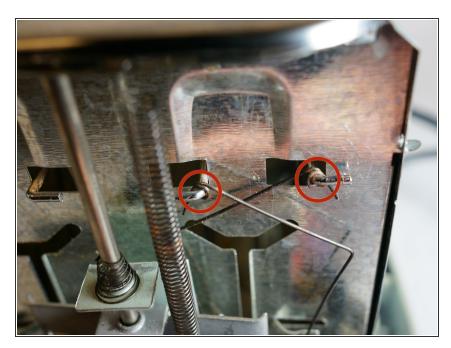
Locate the grabber spring.

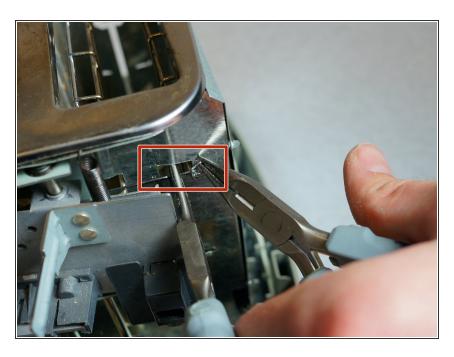
# Step 8

- Use the large needle nose pliers to unwind the grabber spring from one side of the carriage to remove.
- Repeat this step for the opposite side.

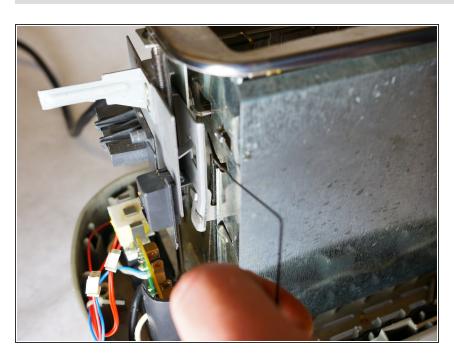
Remove the old spring from the toaster unit to insert new.

To reassemble your device, follow these instructions in reverse order.
