# Texas Instruments TI-5130 Printer Unit Replacement

Follow this guide to remove and replace the printing unit in the TI-5130 electronic calculator.

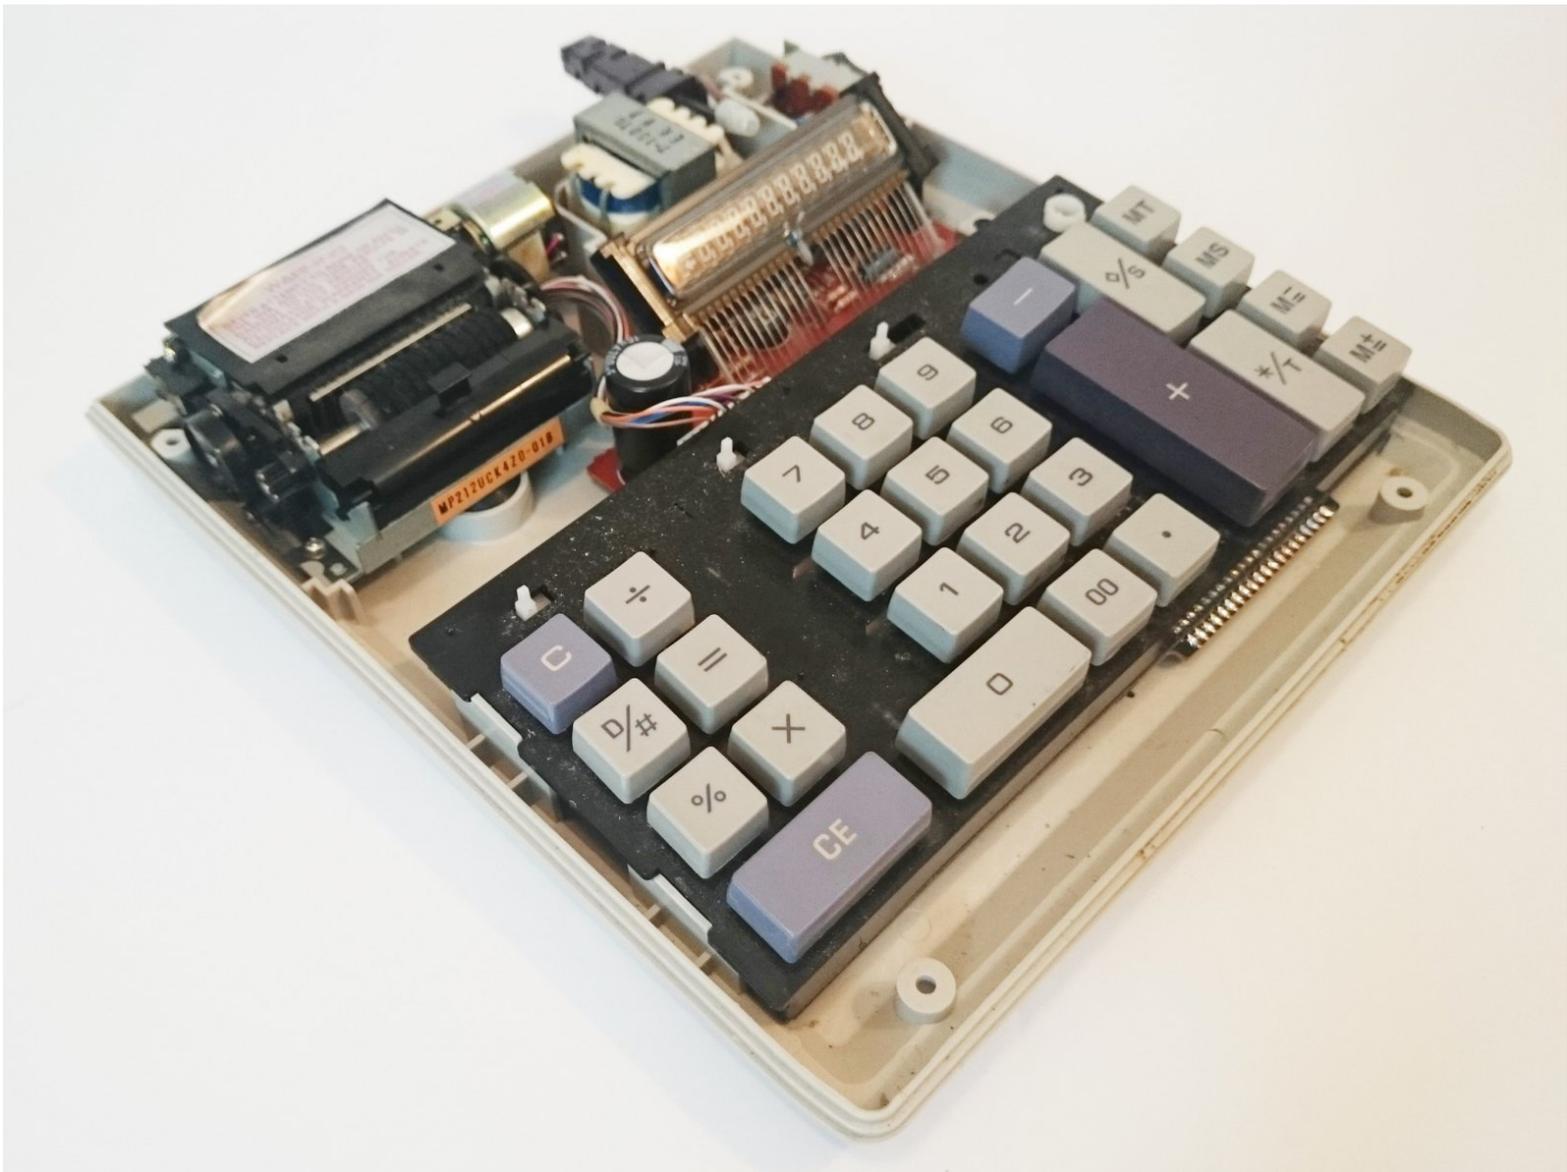
If your calculator has stopped printing and/or will not feed paper you may need to replace the printing unit, shown here.
