# Microsoft Lumia 535 Charging Port Dock and Microphone Flex Replacement

Lumia 535

RM-1090 / RM-1091/ RM-1089 / RM-1092

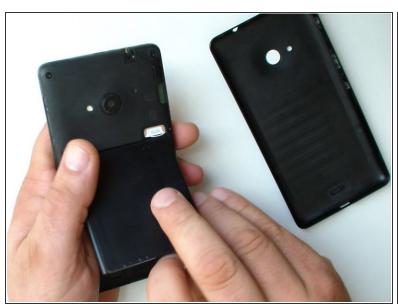
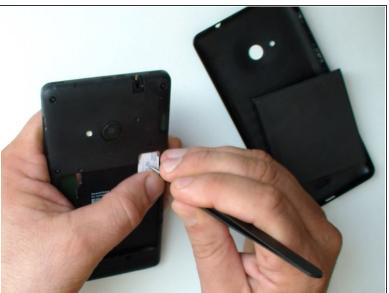
## **Step 1 — Back Cover / Rear Case**

- Turn off the phone.
- Remove the battery and any SIM and memory cards.

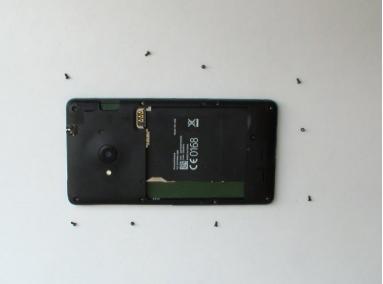
# Step 2

With a screwdriver Torx T4 remove the 9x screws.
